CASE STUDY

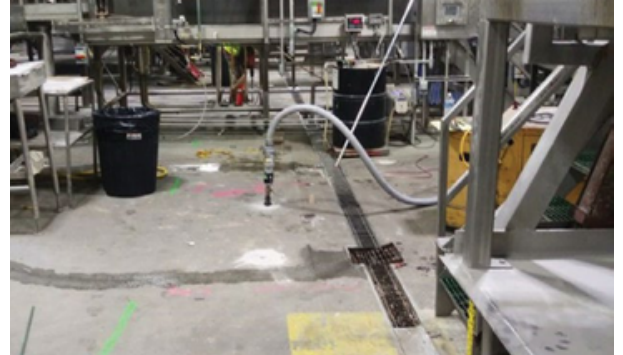
It was identified that there was a failure in the floor drainage of a food production facility. This slow drainage resulted in a major void and multiple pipe breaks. Because this facility was held to strict sanitation requirements, the equipment and floor was washed down regularly, resulting in water draining into the compromised piping washing away valuable fill material. What started with only drips of water and small particles washing away, developed into a major problem. The primary void was 60ft long and was a void size of 4'x4'feet at the worst area. The void ran perpendicular to the main forklift aisle. The worst part of the void was directly under the aisle. As soon as these voids were identified the entire factory was shut down. This factory shutdown cost the plant millions of dollars in downtime and loss of production.
