22 September 2022

RE: Preliminary Geologic and Geotechnical Evaluation and Annual Observation Services
Magee Ranch Open Space
Danville, California
CE&G Document 220560-001

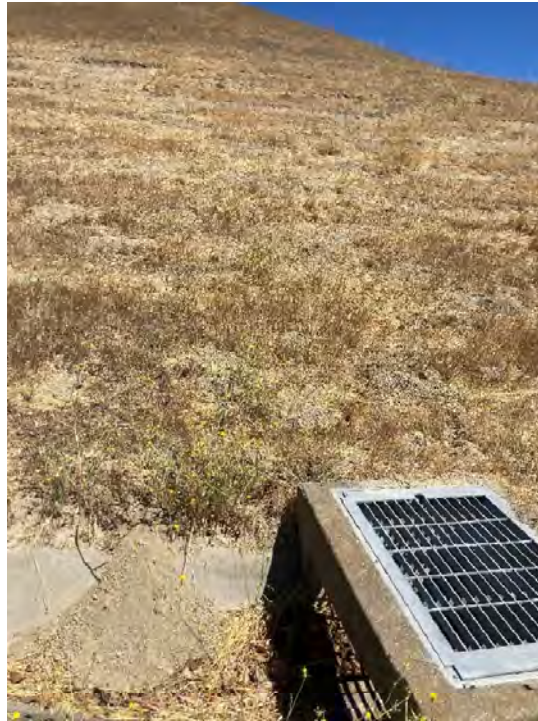
In general, the graded slopes are performing as intended. Deep-seated movement or reactivation of the areas that received remedial grading or repairs of the landslide features was not observed. Portions of these graded slopes have experienced areas of severe soil creep and isolated shallow slope failures. Additionally, isolated areas within these graded slopes have experienced some localized areas of erosion and activity from rodent burrows (Photo 1).

Photo 1. View of soil creep and rodent burrows on the previously graded slope above Brightwood Circle.

It is recommended that the condition of the graded slopes be observed on an annual basis. The observation should be completed before the winter storm season. Additional monitoring is recommended following periods of significant rain and a large seismic event. Additionally, particular attention should be given to the previously repaired slope behind 15 Brightwood Drive where extensive burrowing and creep were observed. The shallow

movement and loose soil has impacted the v-ditch and drop inlet below. We recommend monitoring this area bi-annually before and following the winter storm season.

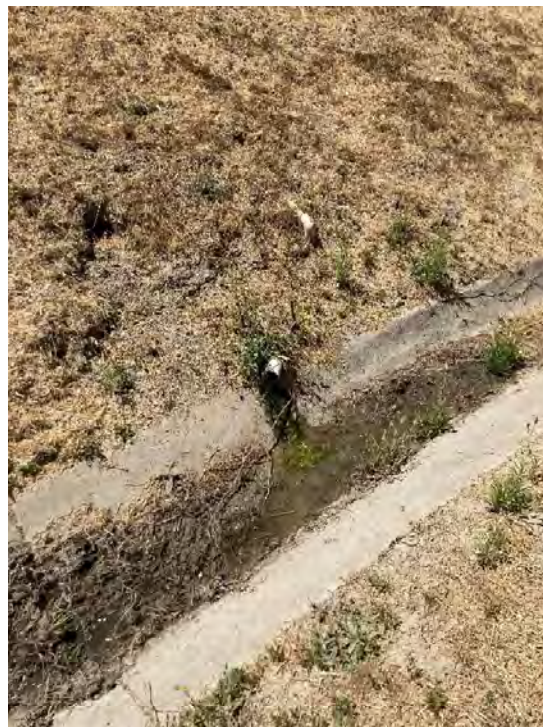
Photo 2. View of subdrain pipe discharging into a concrete-lined v-ditch.

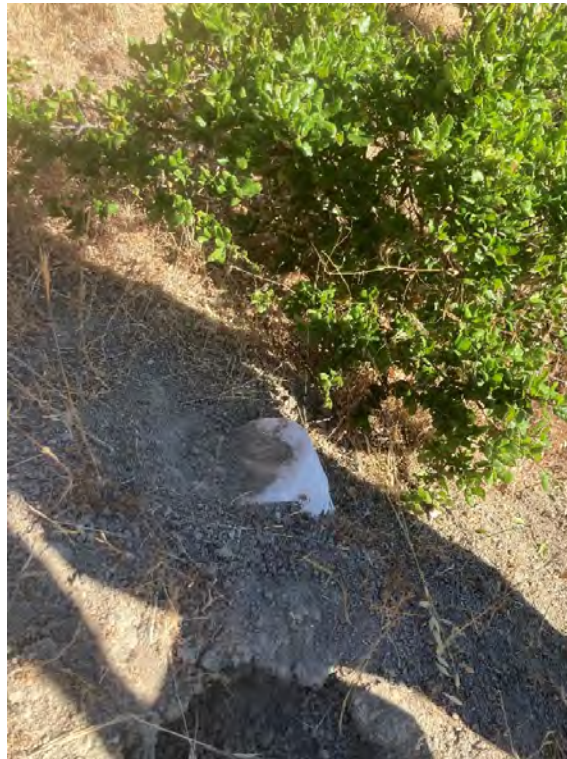
Photo 3. View of subdrain cleanout near ground level and obscured by vegetation.

the as-built plans, damage from past activities, or being buried due to soil creep. Consideration should be made to locating each cleanout riser identified on the as-built plans, extending them above the ground surface, and repairing/cleaning the subdrain system as warranted. Maintaining the subdrain system's functionality will reduce the potential for the repairs to fail and will reduce the risk to nearby improvements.

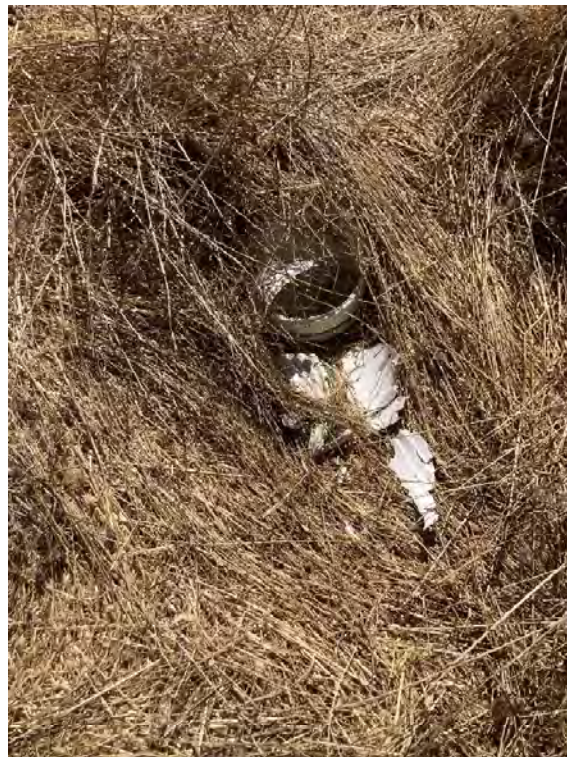
Photo 4. View of subdrain cleanout at ground level, hidden by vegetation, damaged, and missing a cap.

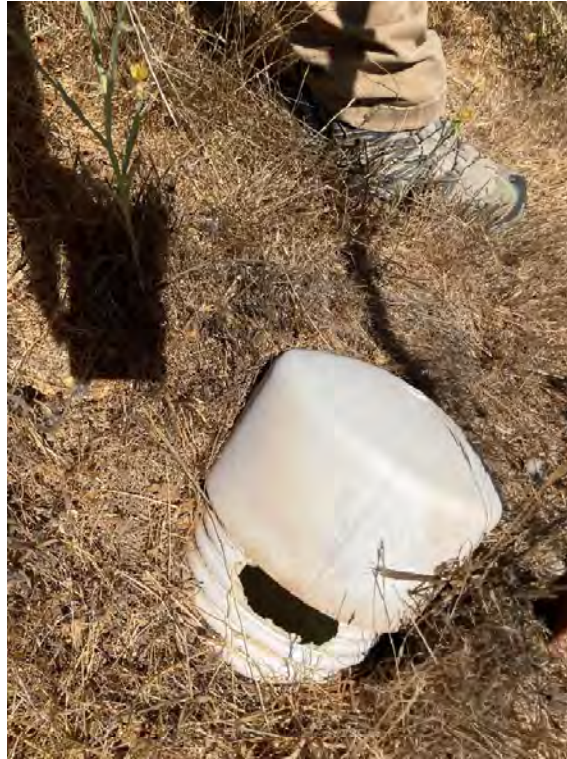
Photo 5. View of a damaged subdrain cleanout riser.

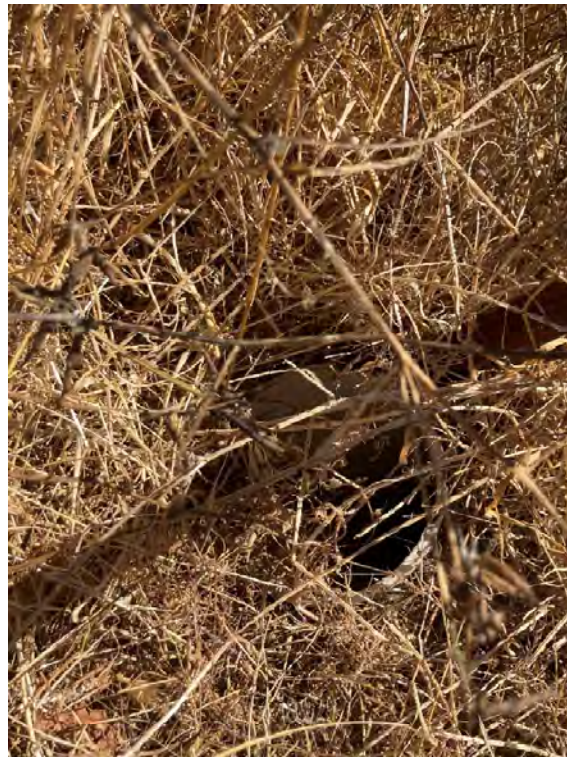
Photo 6. View of a subdrain cleanout riser missing a cap and debris allowed to enter the pipe.

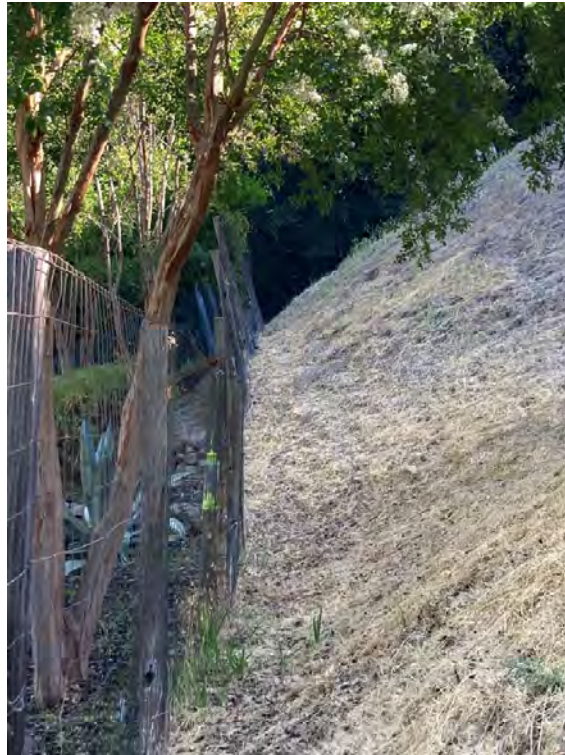
Photo 7. View of a shallow landslide impacting fence line to property below.

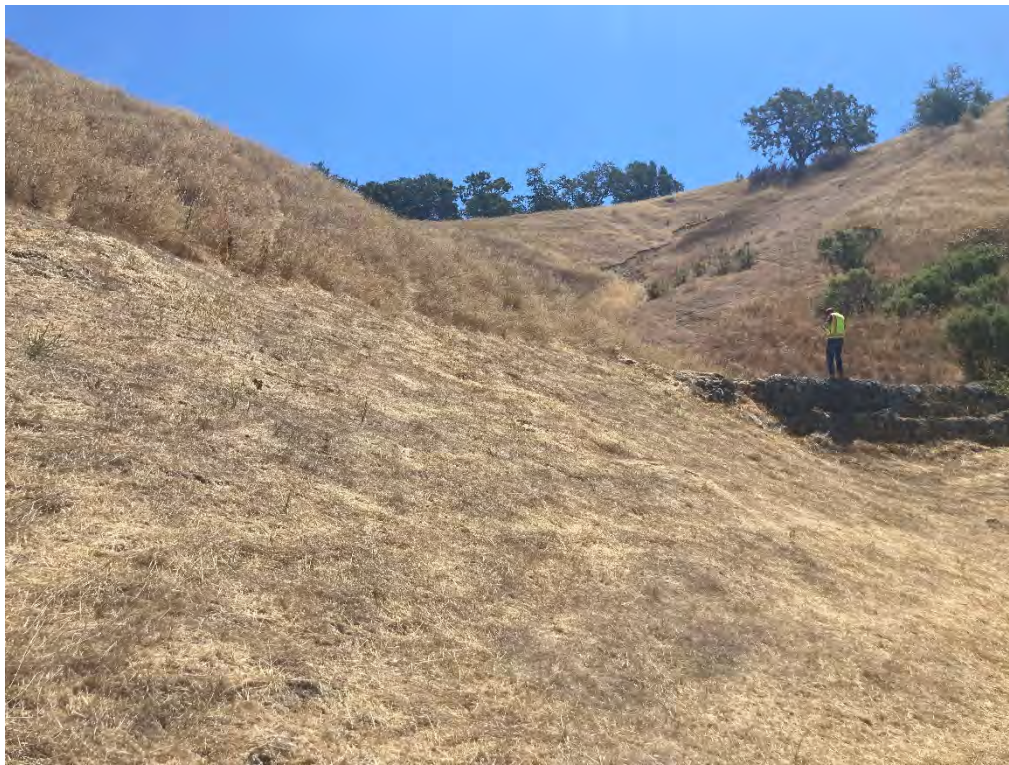
Our August 2022 observations indicate the large landslide complex behind 124 Shadewell Drive appears to be active. Observations of fresh head scarps, areas of bare soil, and increased moisture compared to other areas in the vicinity indicate the slide-prone area has ongoing downslope migration of the landslide debris (Photo 8). Significant amounts of soil have been deposited behind the gabion wall at the base of this landslide complex indicating this has been an ongoing and progressive occurrence (Photo 9). Additionally, a 3-foot-tall steel post and wood lagging catchment wall was observed behind the residence. This wall is leaning and has several feet of material retained behind the wall (Photo 10).

Photo 8. View of recently active landsliding behind 124 Shadewell Drive.

The slide complex behind 124 Shadewell Drive has deposited significant amounts of debris behind the gabion wall near the base of the slope. We recommend the removal of the deposited material and restoring capacity in the basin behind the wall. Additional remedial measures for the gabion wall are not warranted at this time. Evidence of recent movement in this area indicates that landsliding is progressive and ongoing. We recommend monitoring this area a minimum of bi-annually before and following the winter storm season. This area should also be monitored following periods of intense rainfall or a large seismic event. If evidence of increased risk to downslope improvements is observed, consideration for additional remedial or protective measures should be made. Consideration should also be made to repairing or replacing the failing wood catchment wall near the base of the slope behind the residence.

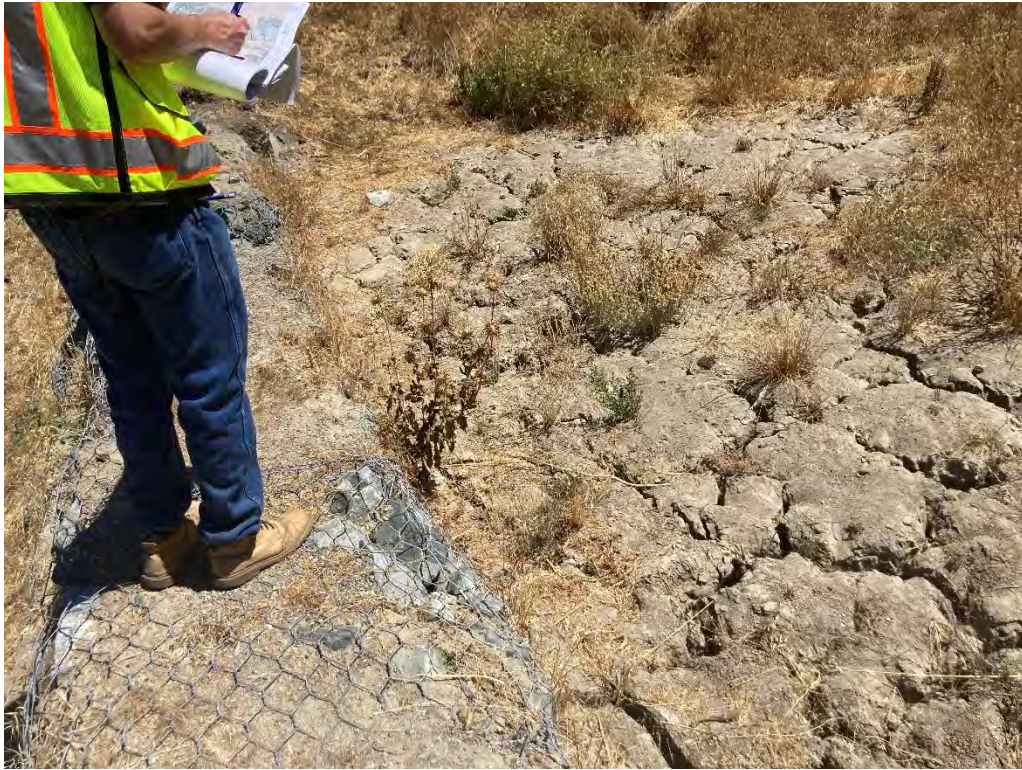
Photo 9. View of a basin behind gabion wall upslope of 124 Shadewell Drive full of sediment/debris.

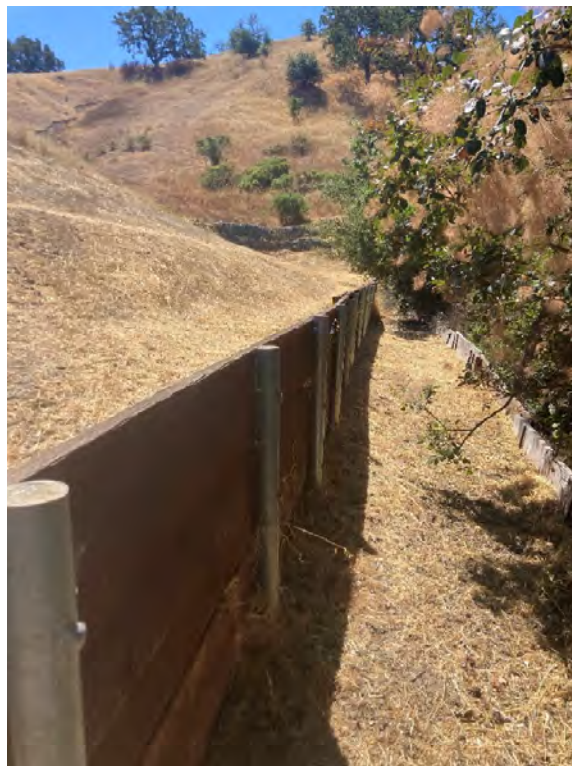
Photo 10. View of a leaning wall behind 124 Shadewell Drive.

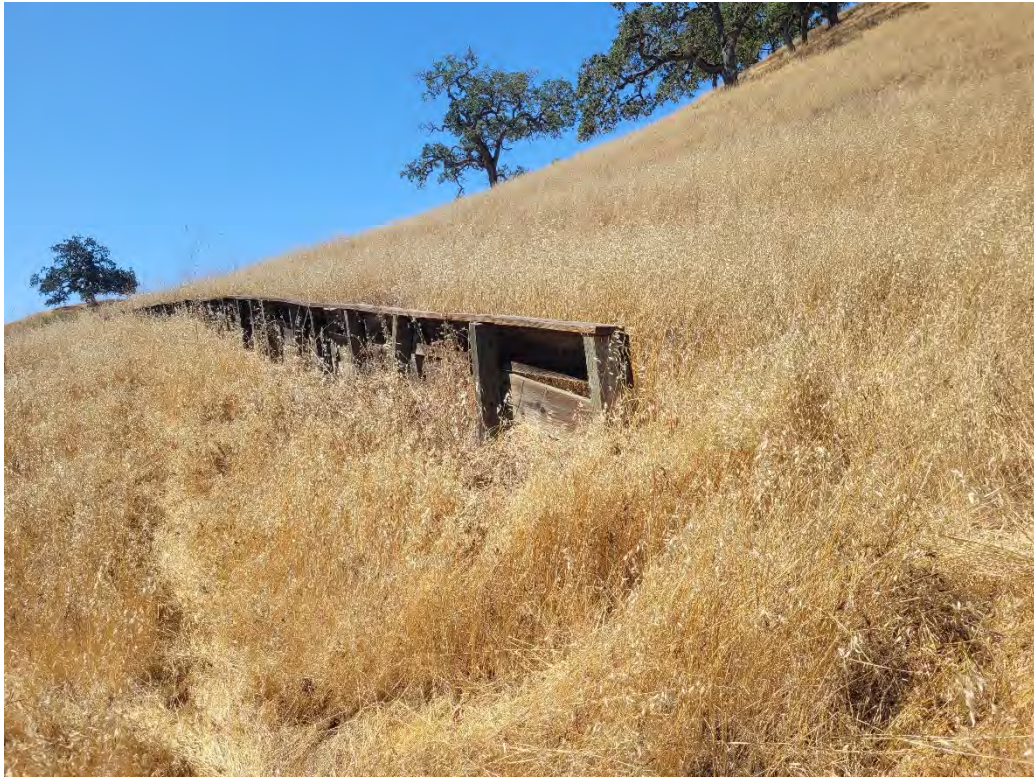
Near the northeastern corner of the project site and upslope of Saddleback Drive, a small to medium size landslide feature was observed. This feature appears active as evidenced by a somewhat fresh headscarp. Near the toe of this feature is an older 3-foot-tall wood catchment wall. This wall was observed as failing (Photo 11). A new cast-in-place retaining/catchment wall was observed at the base of the slope along Saddleback Drive below this feature. This structure was observed in good condition.

Photo 11. View of a failed wood catchment wall upslope of Saddleback Drive.

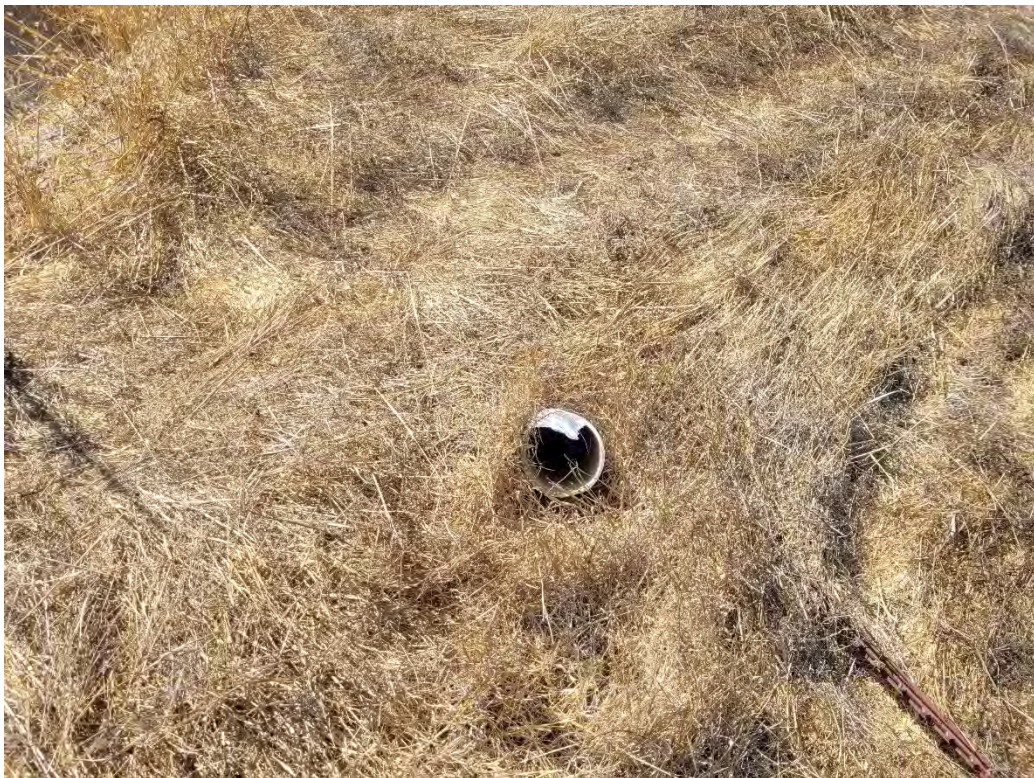
Photo 12. View of a damaged cleanout riser without a cap – debris observed within pipe and the T-post marker knocked over.

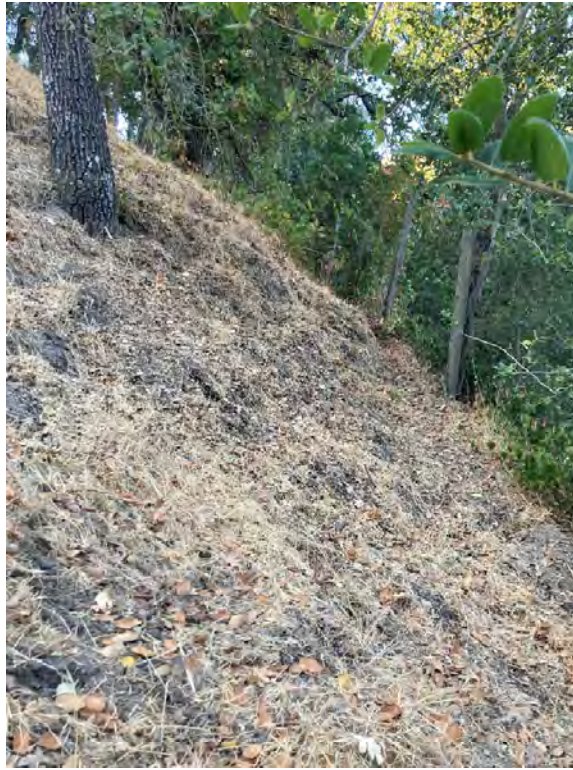
Photo 13. View of creeping soil impacting fence line.

It is recommended that the areas of active soil creep be observed on an annual basis. Any significant changes should be noted and documented. Consideration may be made to reducing the potential for soil entering the surface drainage facilities in the areas where the soil has been observed cascading in into the v-ditches and drop inlets. This may be accomplished by removing of the soil directly upslope and adjacent to the v-ditches and drop inlet structures and installing straw wattles along the upslope sides of the v-ditches.

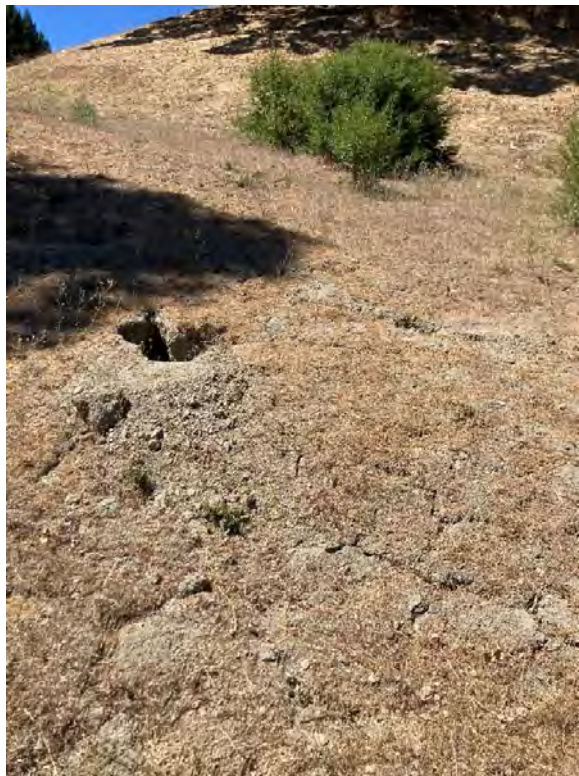
Numerous animal and or rodent burrows were observed at various locations within the hillside areas. The burrows were often located adjacent to and above the concrete-lined v-ditches. These burrows have resulted in the deposition of excess soil into the v-ditches and some undermining of the v-ditches at some locations (Photo 14). These burrows can reduce the underlying support of the ditch, increase the potential for excess cracking or offsets within the ditches, reduce the functionality of the surface drainage facilities via the introduction of debris into the system, and have the potential to create potential localized shallow landsliding or slumping within the hillside areas.

Photo 14. View of an animal burrow within shallow slope failure.

We recommend that areas, where undermining of the v-ditches has occurred, should be repaired. This may be accomplished by filing the burrow's void with the placement of neat cement grout or compacted soil under the v-ditches.

It is recommended that the areas with significant animal burrow activities be monitored for future movement. Repair of soil slumping would be warranted if the soil moves downslope and impacts the surface drainage facilities or other improvements. Consideration should be given to implementing a rodent abatement project for these areas.

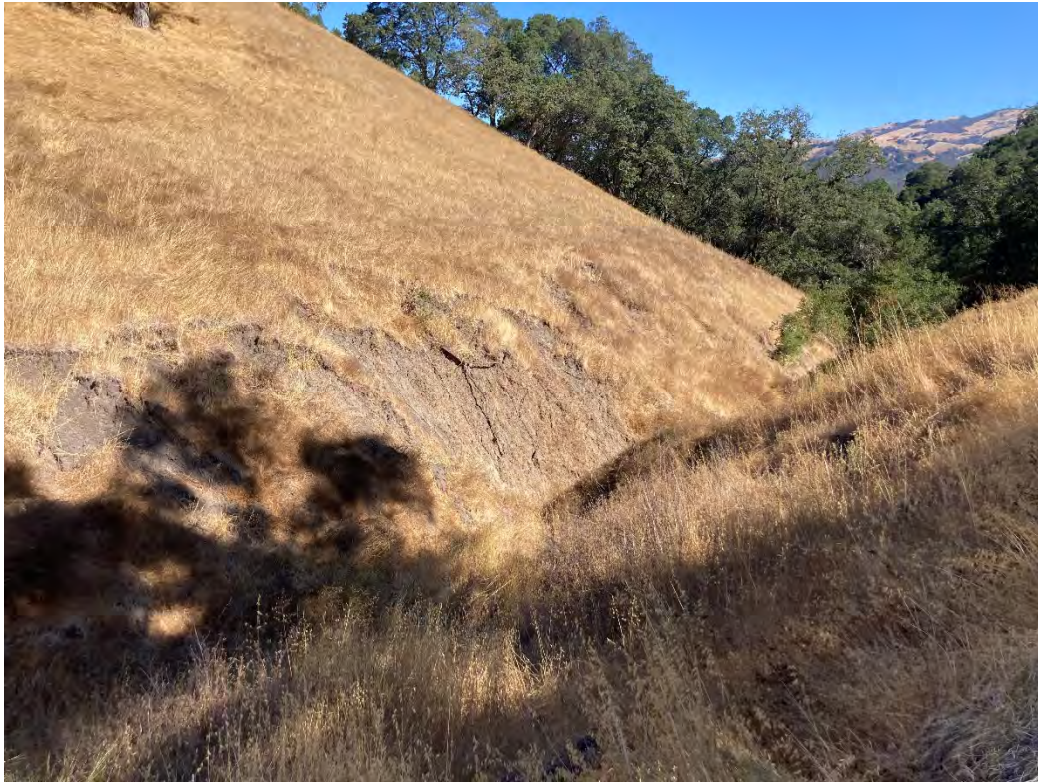
The drainage ravine to the south of 138 Windover Drive has experienced significant erosion, downcutting and embankment failures (Photo 15). The result of this has been the significant deposition of sediment into the three basins south of 138 Windover Drive. Our observations indicate that previous attempts to limit this downcutting have been made. A rip-rap blanket was installed at the southern end of this erosion-prone area as an energy dissipation structure for the outlet pipe for the basin to the south (Photo 16). However, the drainage from this 8-inch pipe has resulted in the migration of the drainage pathway west of the rip-rap blanket. Downcutting appears to be ongoing and progressive.

Photo 15. View of the significant erosion in the drainage channel south of 138 Windover Dr.

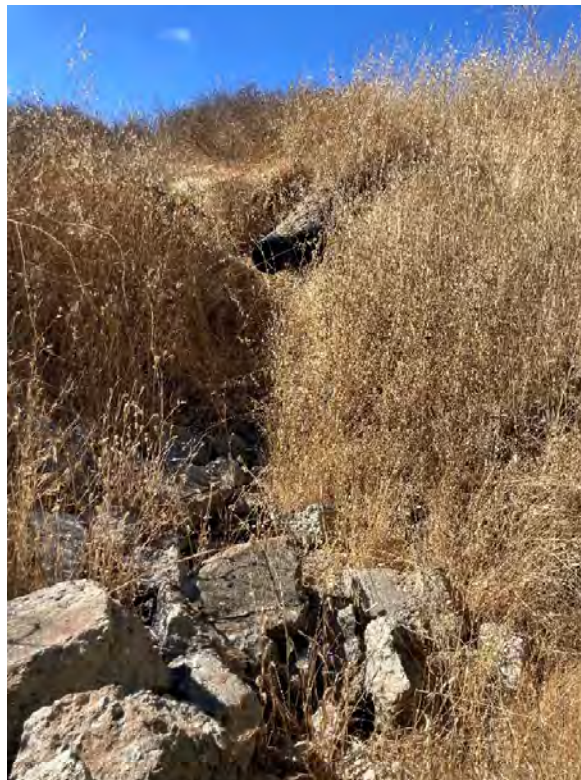
Photo 16. View of an 8-inch outlet pipe with downcutting along limits of rip rap.

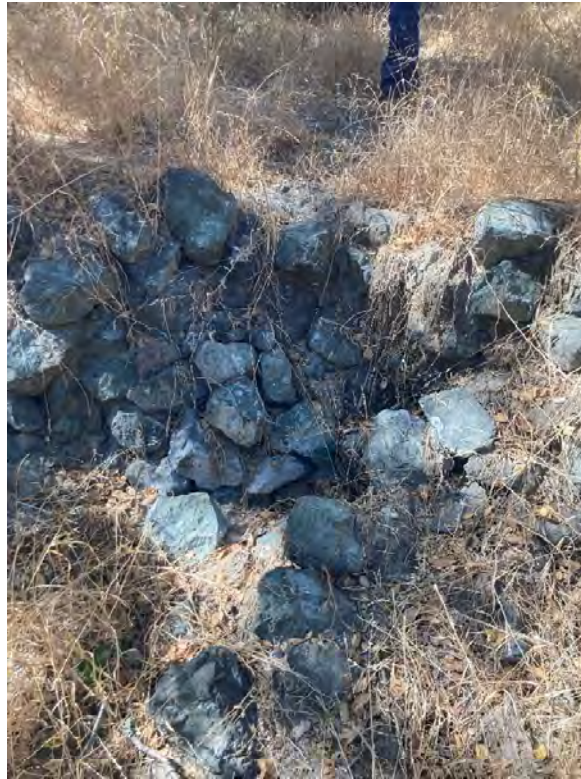
Photo 17. View of the failed stacked rock wall south of 138 Windover Drive.

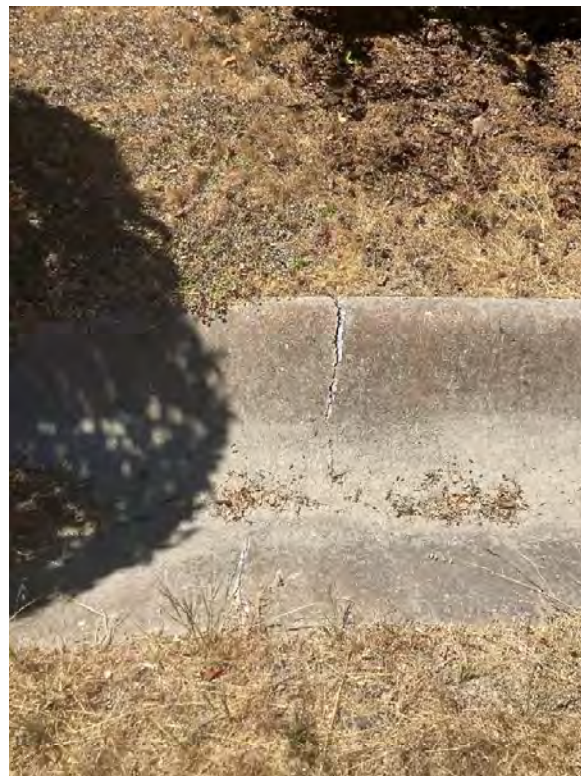
Photo 18. View of minor cracking of concrete-lined v-ditch.

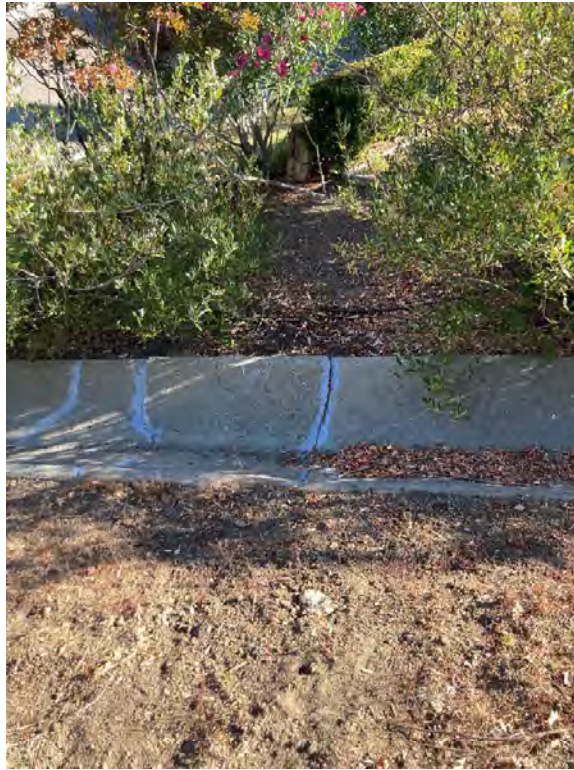
Photo 19. View of ongoing cracking at previous repair location within the v-ditch.

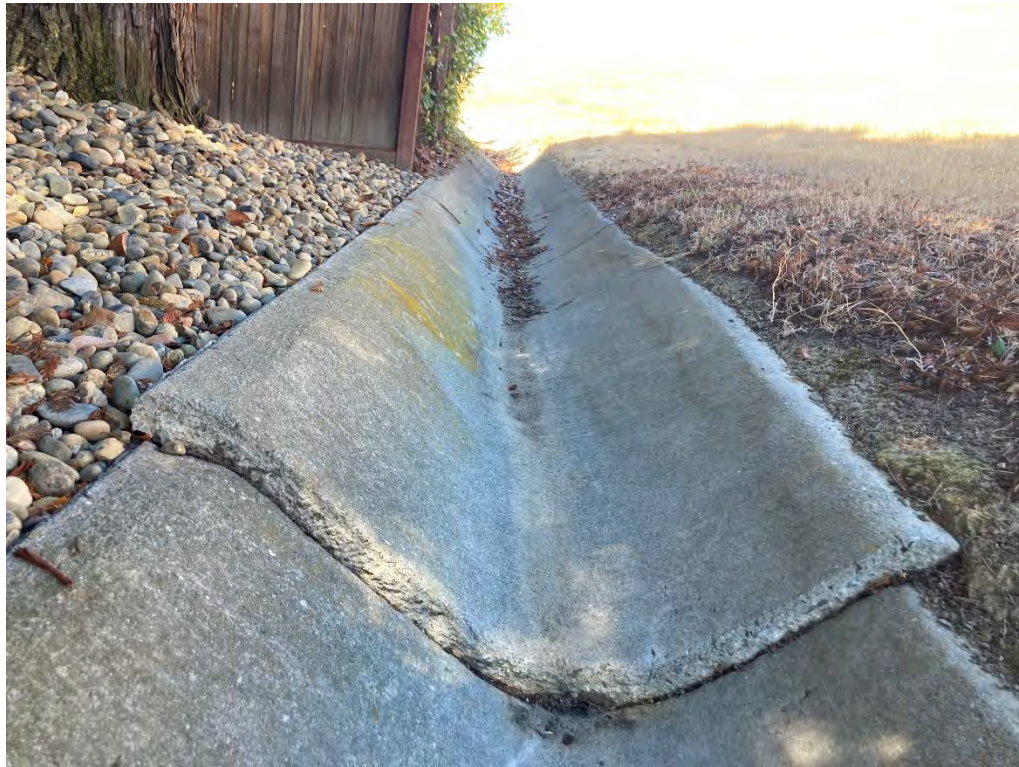
Photo 20. View of a vertical offset of a v-ditch.

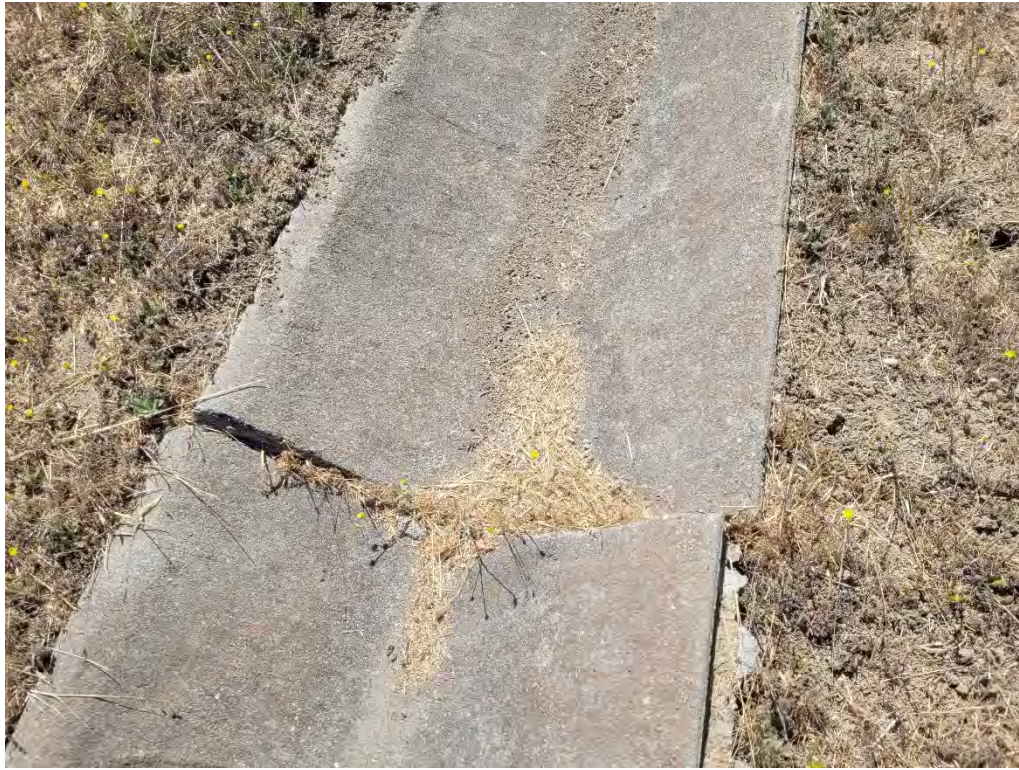
Photo 21. View of horizontal and vertical offsets with damming impacting flows of v-ditch.

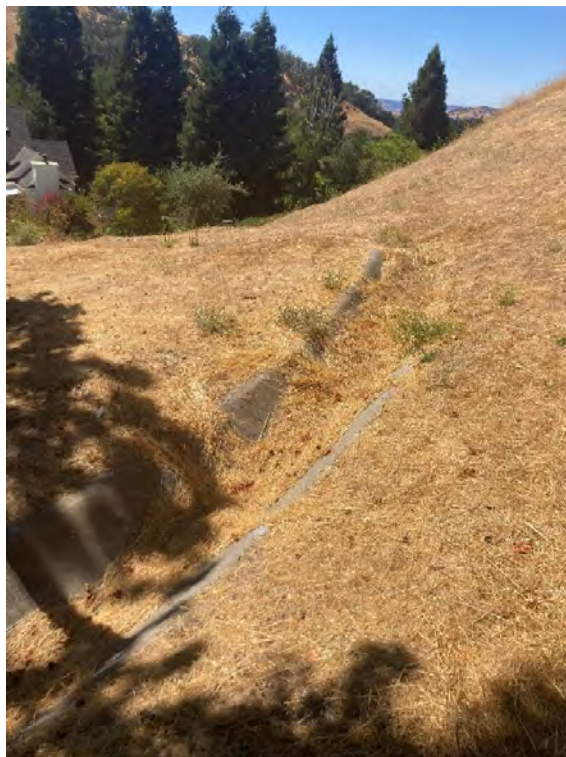
Photo 22. View of vegetative debris in v-ditch.

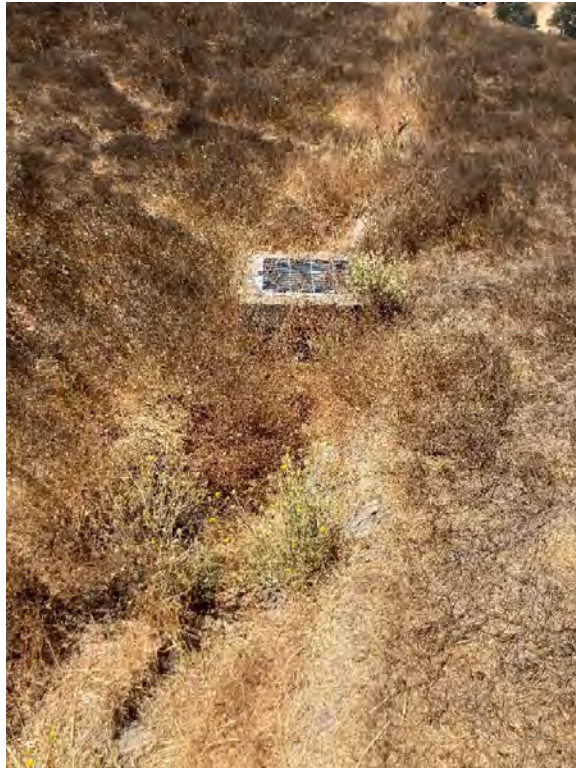
Photo 23. View of significant vegetative growth in and adjacent to the v-ditch.

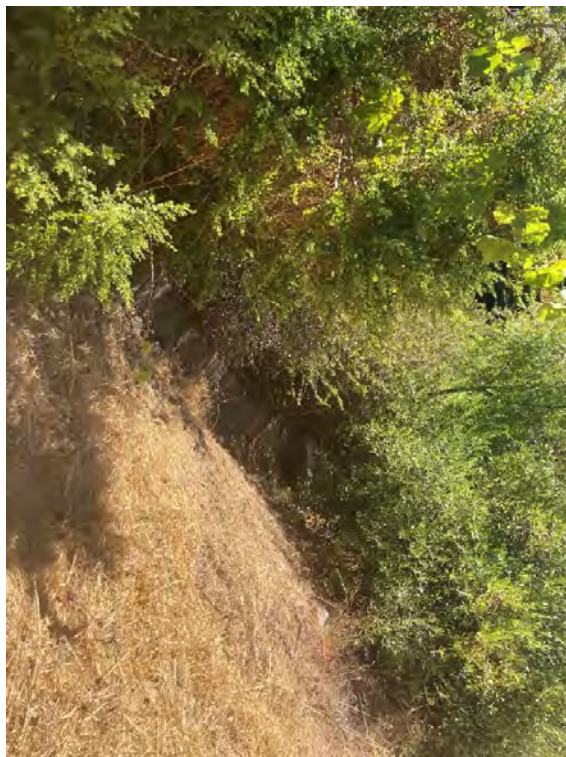
Photo 24. View of vegetation overhanging the v-ditch.

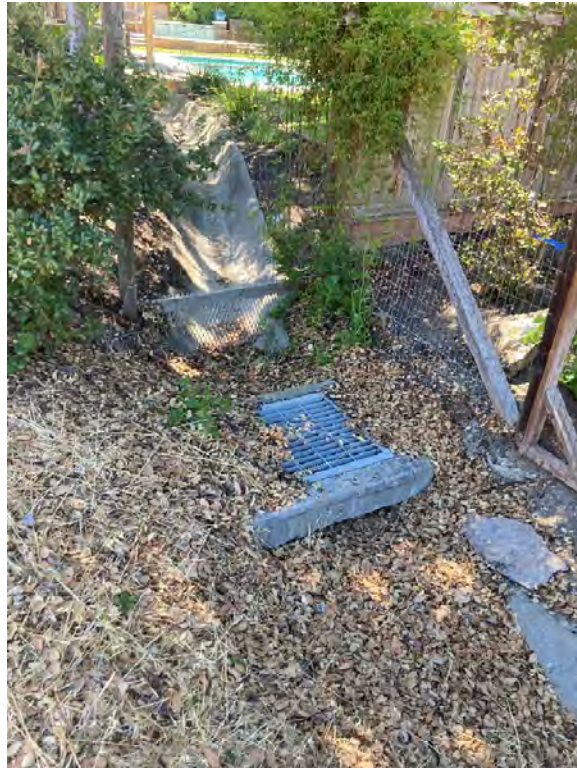
Photo 25. View of debris blocking drop inlet.

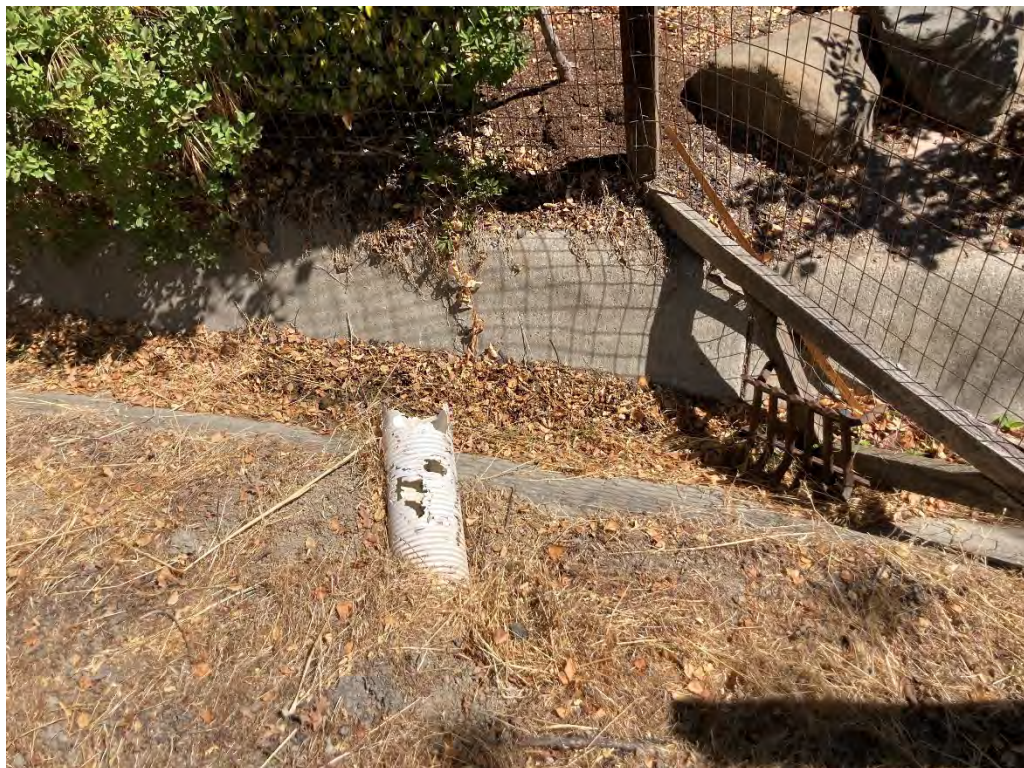
Photo 26. View of an outlet pipe into v-ditch, outlet pipe is damaged.

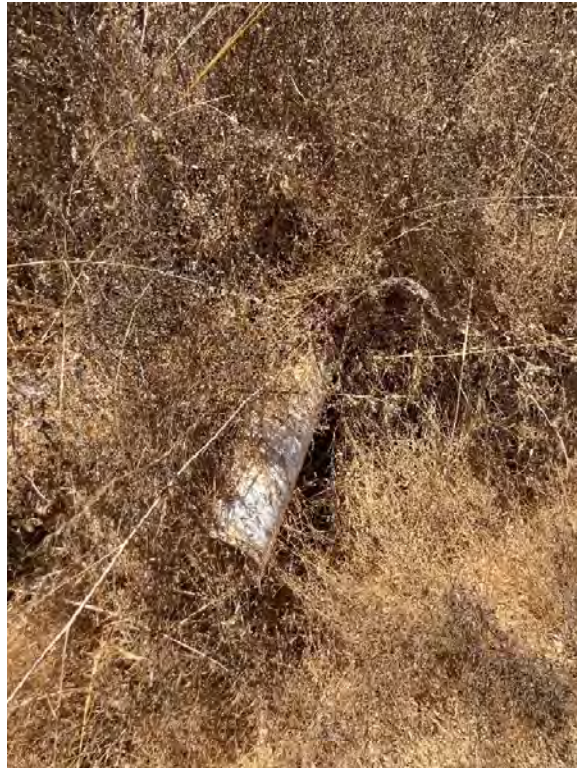
Photo 27. View of a subdrain outlet pipe blocked by vegetation.

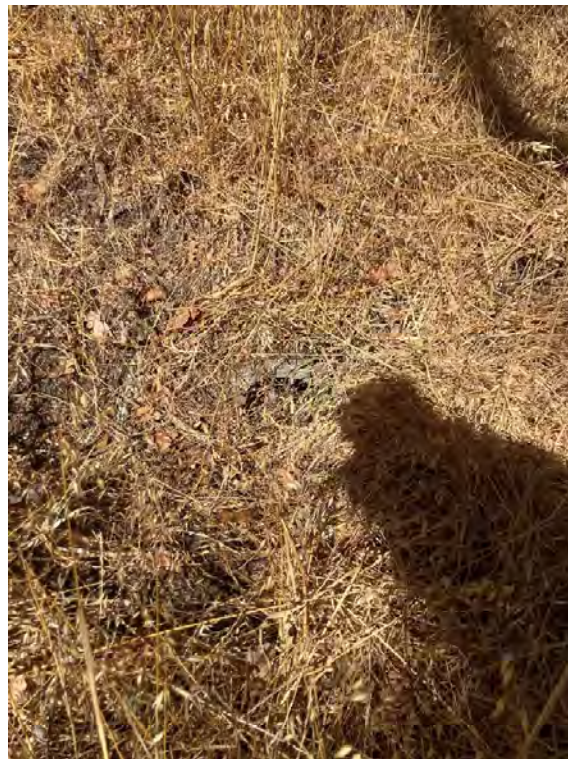
Photo 28. View of the partially blocked inlet for culvert pipe crossing under fire road south of 138 Windover Drive.

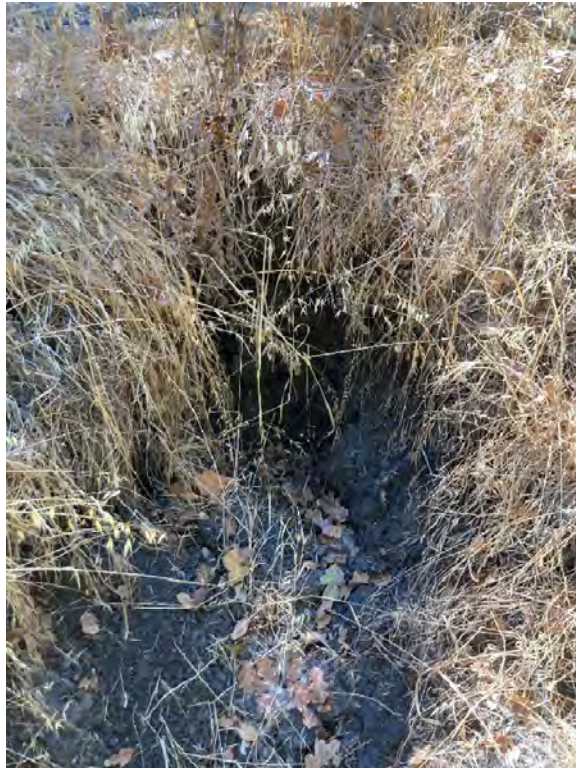
Photo 29. View of the missing section of the culvert pipe outlet crossing under fire road south of 138 Windover Drive.

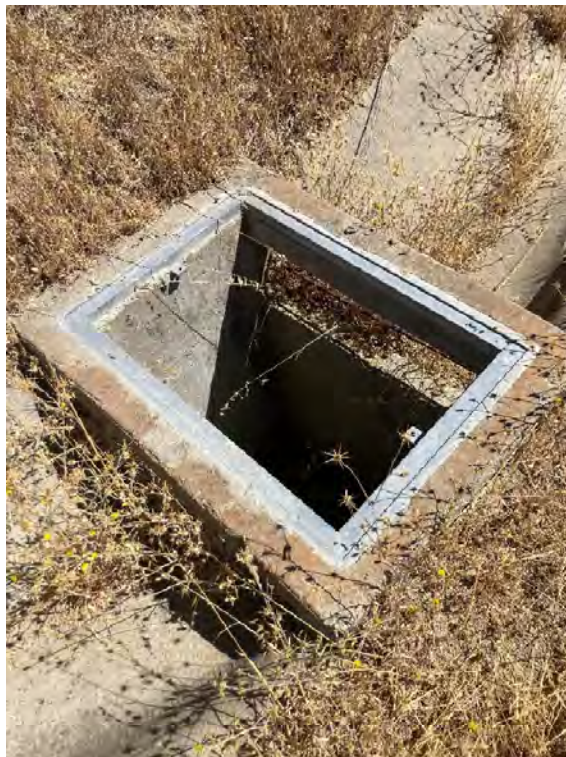
Photo 30. View of missing cover grate for drop inlet near 10 Hunters Terrace.

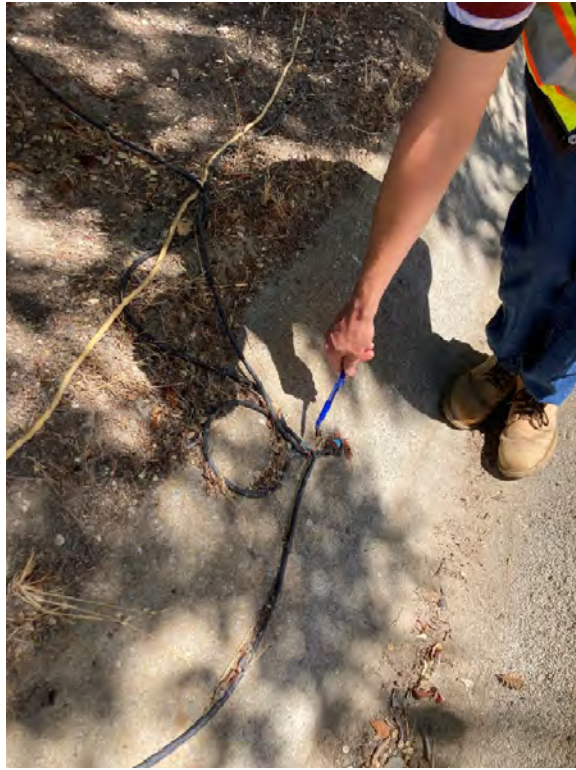
Photo 31. View of exposed wiring in v-ditch behind 102 Shadewell Drive.

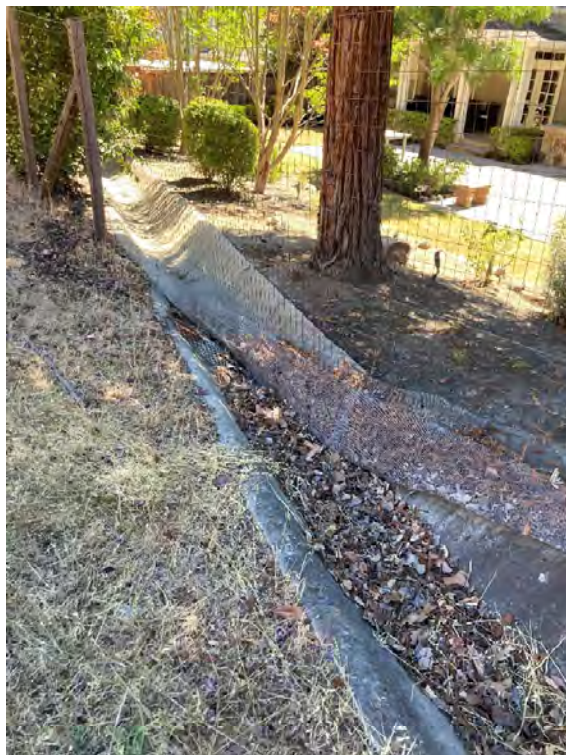
Photo 32. View of fencing extending to v-ditch and blocking debris.

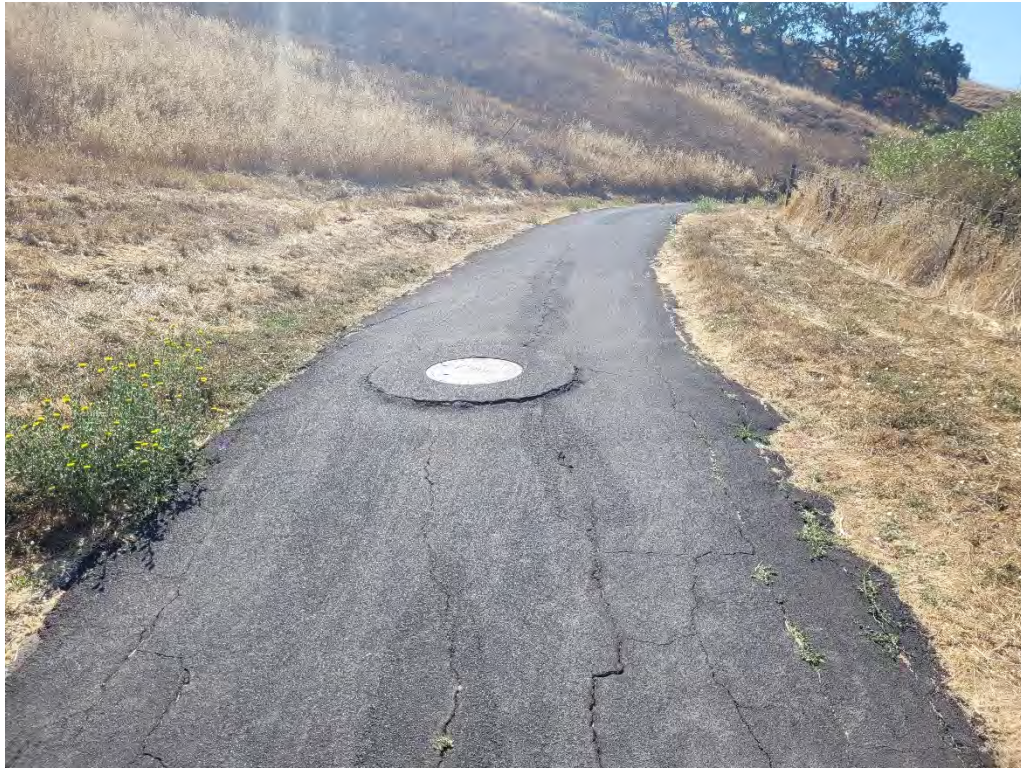
Photo 33. View of pavement cracking and settlement on Sunhaven Trail.
