Tryhorn Consulting

February 17, 2021
TC No. 1006-900

**RE: BIENNIAL (2019 THROUGH 2020) GEOLOGICAL SITE VISIT
MAGEE RANCH
DANVILLE, CALIFORNIA**

Slope and Drainage Monitoring
February, 2021

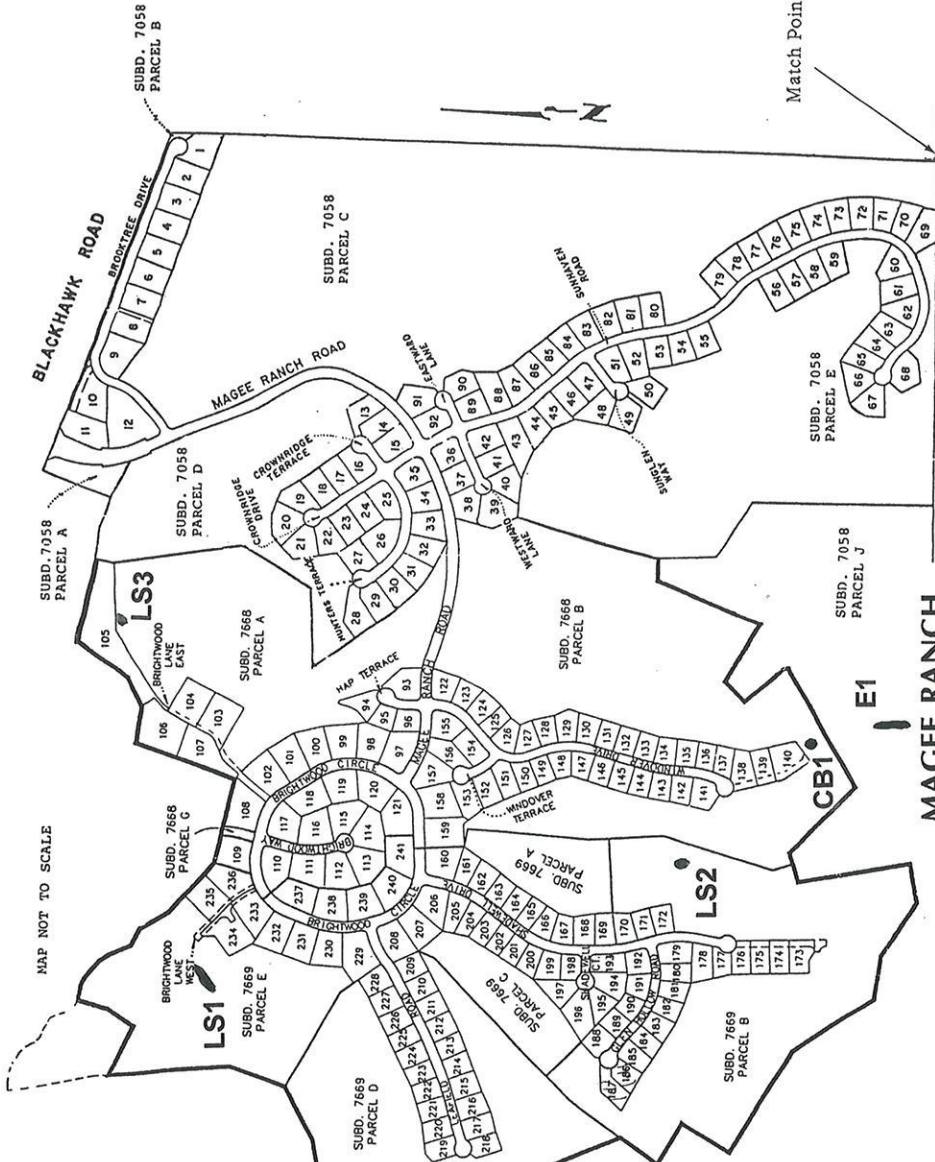
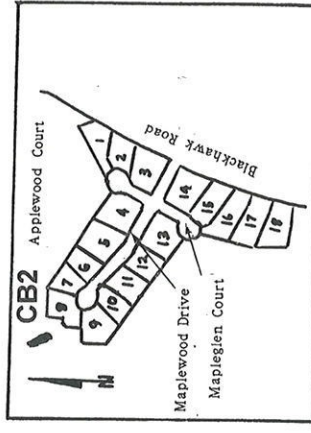
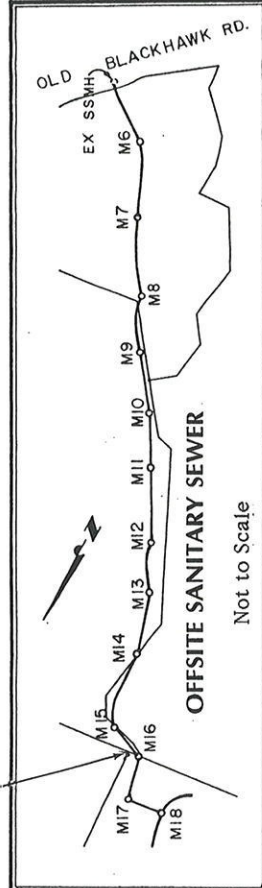
FIGURE 1

During our site visit of February 2020, we observed on the slopes to the southwest of the Detention basin (LS-1), a trail that climbed up at least 400 feet long to the ridge top. The trail had been created by excavation of curves and jumps for use by trail bikes. Tire tracks were evident, and the trail surface was bare soil. We considered the trail to be a severe erosion hazard, and, working with Ron O'Dell, recommended restoration criteria. Adrian Martinez of New West Landscape performed the earthwork and re-sculpting needed to return the slope to its preexisting condition. We observed and walked over the site during our May visit. Adrian had seeded the bare soils, and added wattles, though we suggested that more seeding should be applied just prior to winter rains, and he agreed to add more.

In late October 2020, a large mound of excavated soil spoils was placed on an HOA-managed slope (Location LS-3) near a landslide that was repaired during Magee Ranch site grading and referenced as E-3R. The soil mound was about 450 feet east of the end of Brightwood Lane East, adjacent to the fence line. The soil reportedly has been removed. Because the location is characterized by historic, mapped landslides, monitoring over this winter and beyond is advisable. The slide repair included subdrainage, and we are not aware if the slide soils or subdrains were disrupted by excavation.

- (A) The recently seeded slopes southwest of the Detention Basin, LS-1 on Figure 1, should be observed this winter, particularly following heavy rain periods. The bare slopes of the trail bike tracks are very erodible until vegetation is well established.
- (B) The disturbed slope area at LS-3 on Figure 1 should be monitored throughout the winter so revegetation can be established. If necessary, additional erosion control may be needed, such as wattles and silt fence.

- (B) The check dams and headwall at the head of Windover (Location CB-1 on Figure 1) should be checked during the 2020//2021 winter for collection of silt, as an indicator of upstream erosion. Remedial action may be needed during the winter such as cleaning, removing sediment, or re-stacking of the rock check dams. The current erodible condition may be evaluated for long-term remediation, and work undertaken to slow significantly or cease, future erosion.
- (C) Uphill from 26 Mapleglen Drive in Magee Ranch Terrace (Location CB-2 on Figure 1), the lower two detention ponds should be monitored for erosion and to ensure that the outfall pipes are functional.
