Project No.  
**3417.001.001**

January 7, 2025

Subject: Magee Ranch Development GHAD  
Danville, California

### **MAGEE RANCH GEOLOGIC HAZARD ABATEMENT DISTRICT MONITORING FALL 2024**

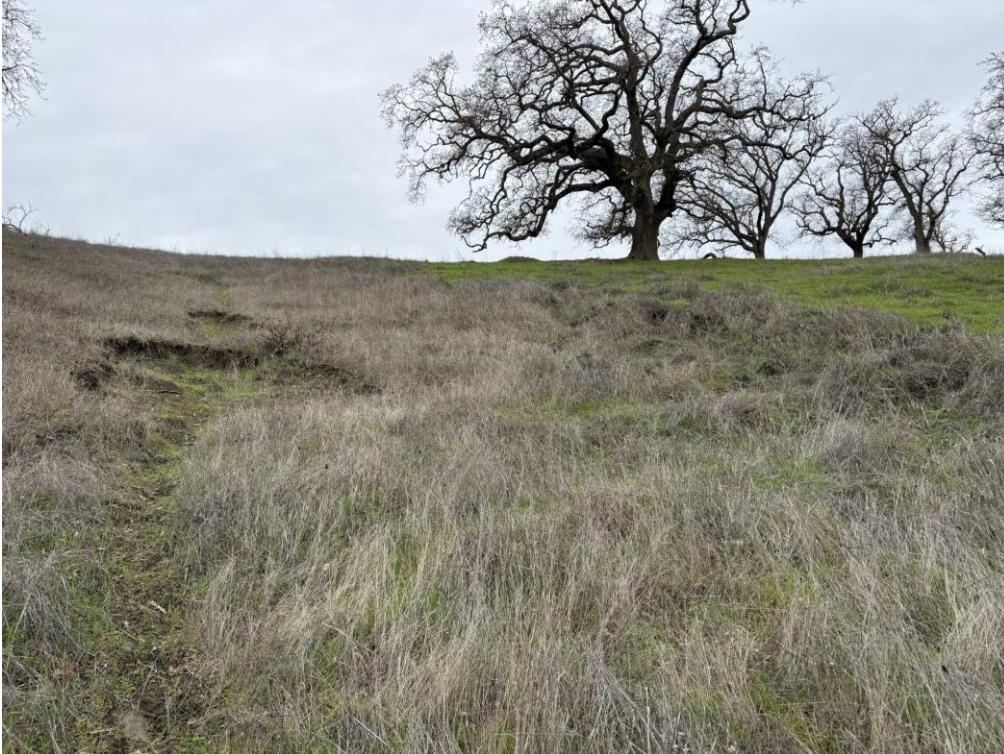
| SITE CONDITION | DESCRIPTION | COMMENTS |
|---|---|---|
| A | Shallow slide, scarp is approximately ½ foot deep and 20 feet wide. Debris accumulates downslope due to erosion during rain events. (Figure 1, Photograph 1). | Continue to Monitor |

**Site Condition A** – Photograph 1 (top), Photograph 2 (bottom)

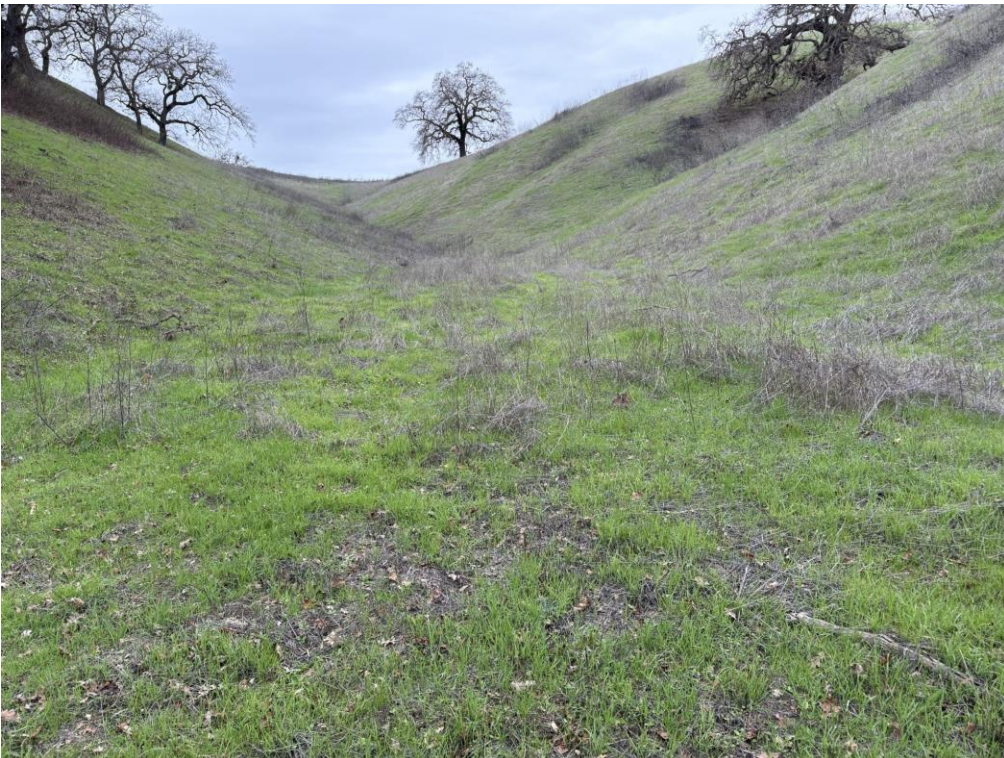
| SITE CONDITION | DESCRIPTION | COMMENTS |
|---|---|---|
| A.4 | Material eroding along concentrated drainage channel and building up at the base of the channel. (Figure 1, Photograph 2). | Continue to Monitor |

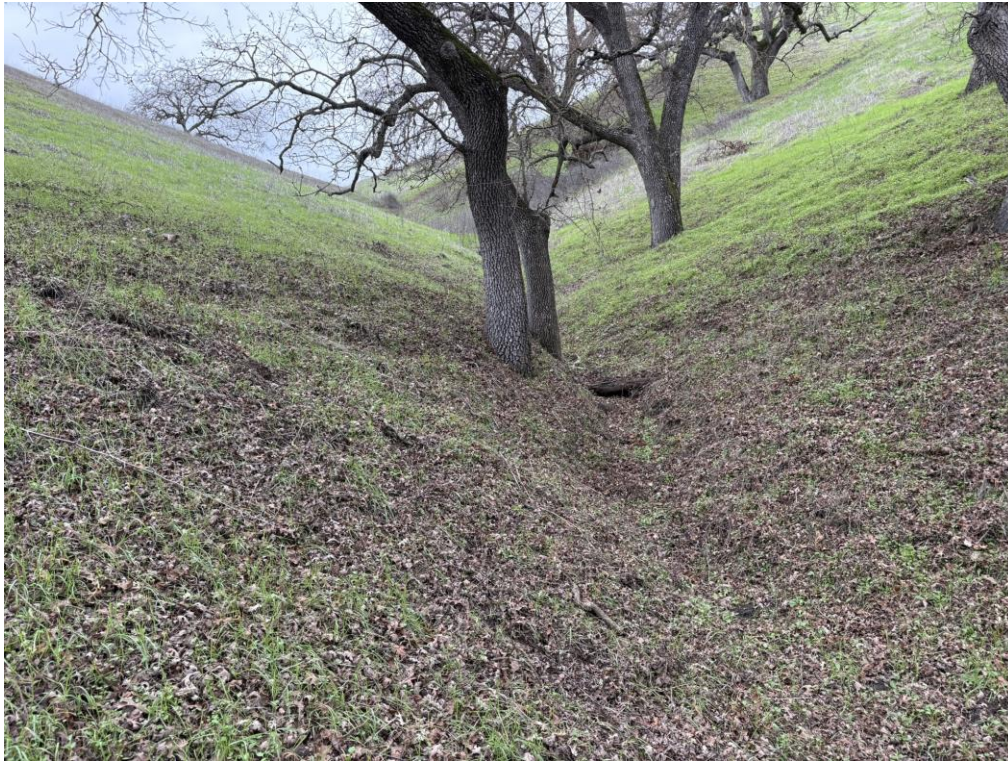
During monitoring, we observed several concentrated drainage areas (Figure 1) that could concentrate water during heavy rainfall events. We observed some mitigation measures in place and evaluated the condition of the walls in a future section. Overall, these areas did not indicate significant mobilization of debris, and the catchment basin areas appeared to be in good condition (Figure 1, Site Condition B, Photograph 3).

| SITE CONDITION | DESCRIPTION | COMMENTS |
|---|--|--|
| B | Natural terrain creates areas of concentrated flow during heavy rainfall events. | Continue to Monitor. GHAD will assess the need for erosion control per monitoring event. |

**Site Condition B – Photograph 3, Concentrated Drainage Area**

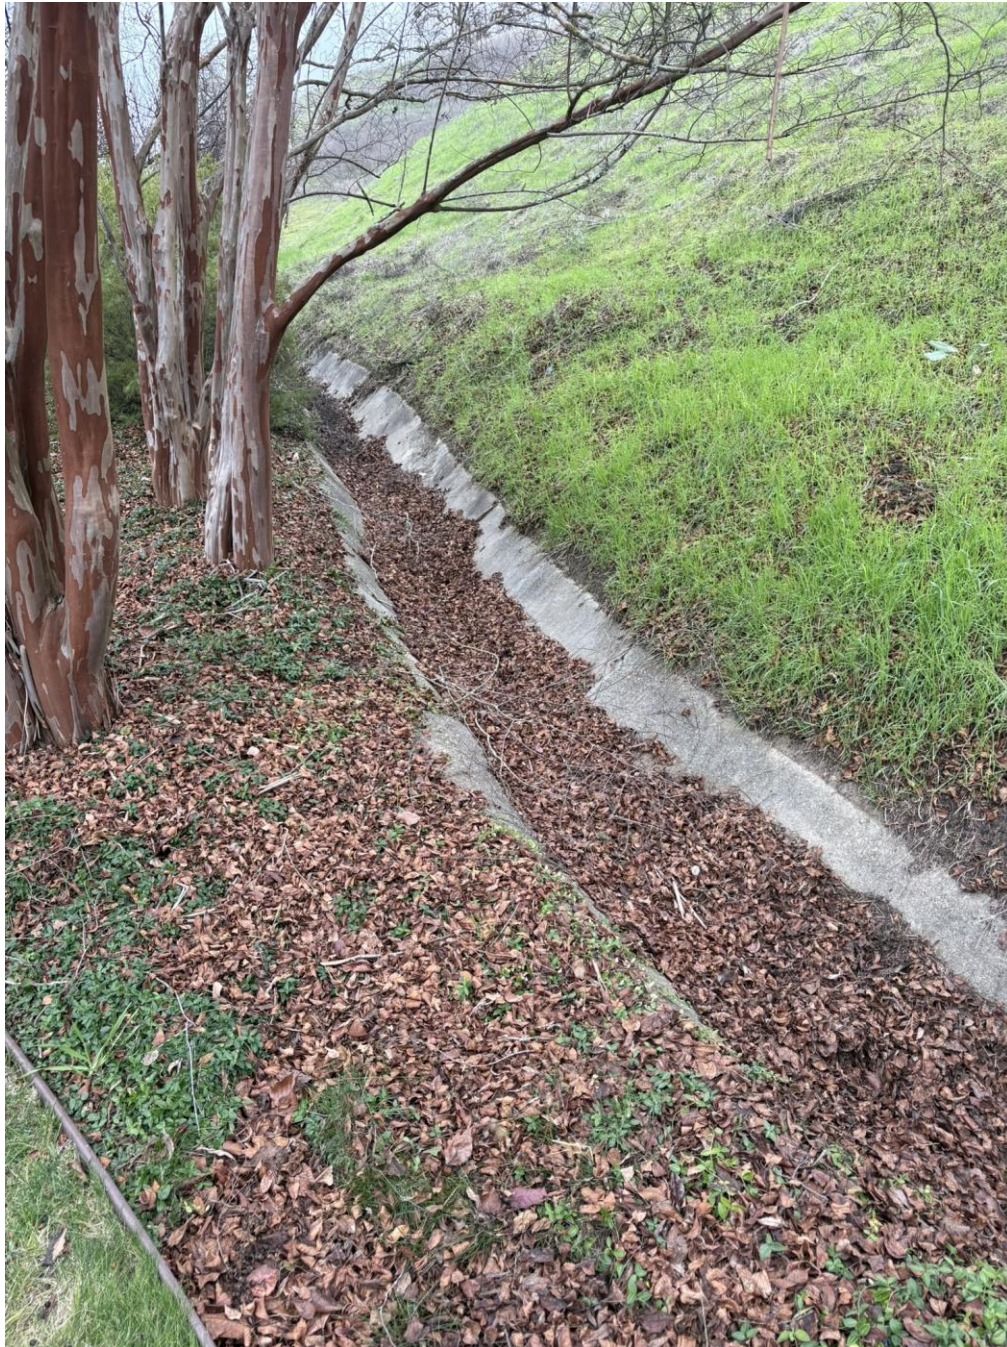
| SITE CONDITION | DESCRIPTION | COMMENTS |
|---|--|--|
| C | Debris accumulating and/or vegetation overgrowth within concrete-lined drainage ditch. | Remove debris and cut back overgrowth from drainage ditch. |

**Site Condition C – Photograph 4, Debris in Concrete-Lined Drainage Ditch**

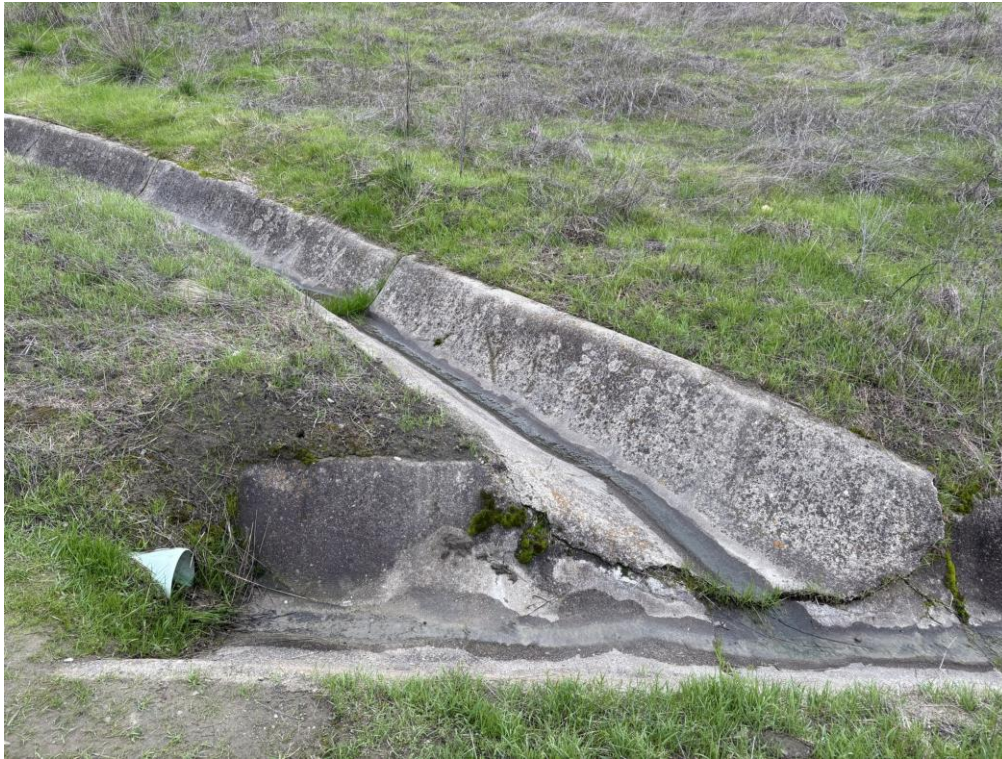
| SITE CONDITION | DESCRIPTION | COMMENTS |
|---|--|--|
| D | Cracking in concrete-lined drainage ditch. | Repair cracking to allow flow within drainage ditch. |

**Site Condition D – Photograph 5, Cracking in Concrete-Lined Ditch**

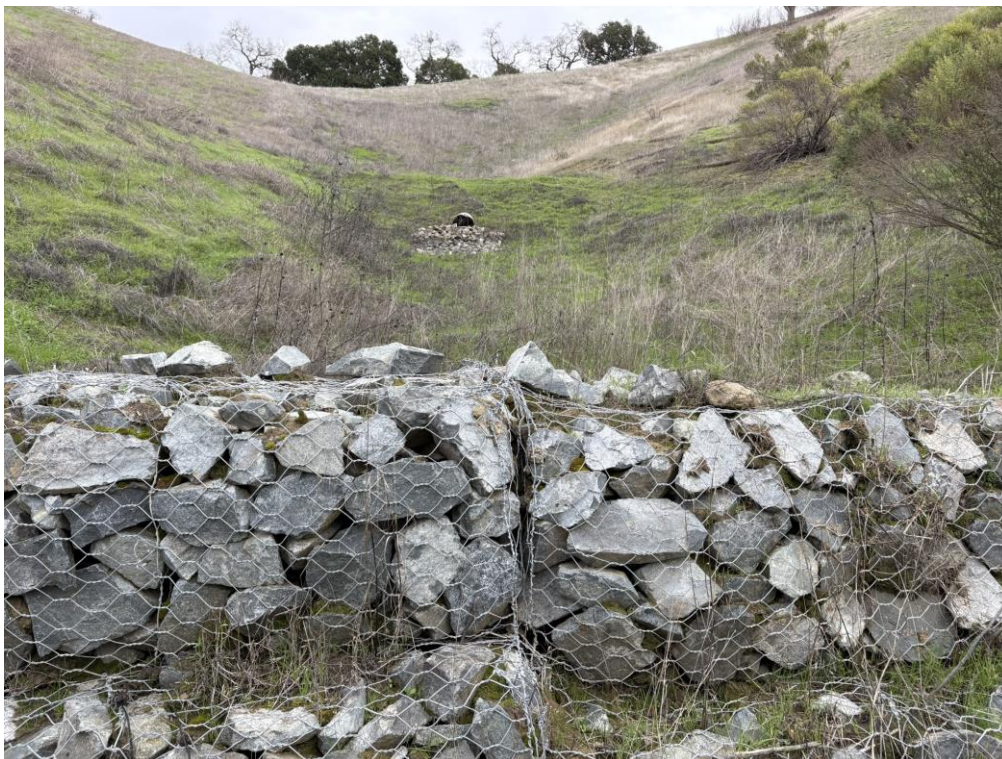
We observed a number of erosion control walls within the GHAD area. These included areas of straw wattle, gabion walls, and soil debris walls (Figure 1, Site Condition E, Photograph 6). We observed the area behind the walls to ensure that mobilized debris would be prevented from running downslope during a future storm event. Removal of built up material behind the walls may be required following future heavy storm events, but overall the walls appeared to be in good condition during our visit.

**Site Condition E – Photograph 6, MSE Walls and Recent Slope Repairs**

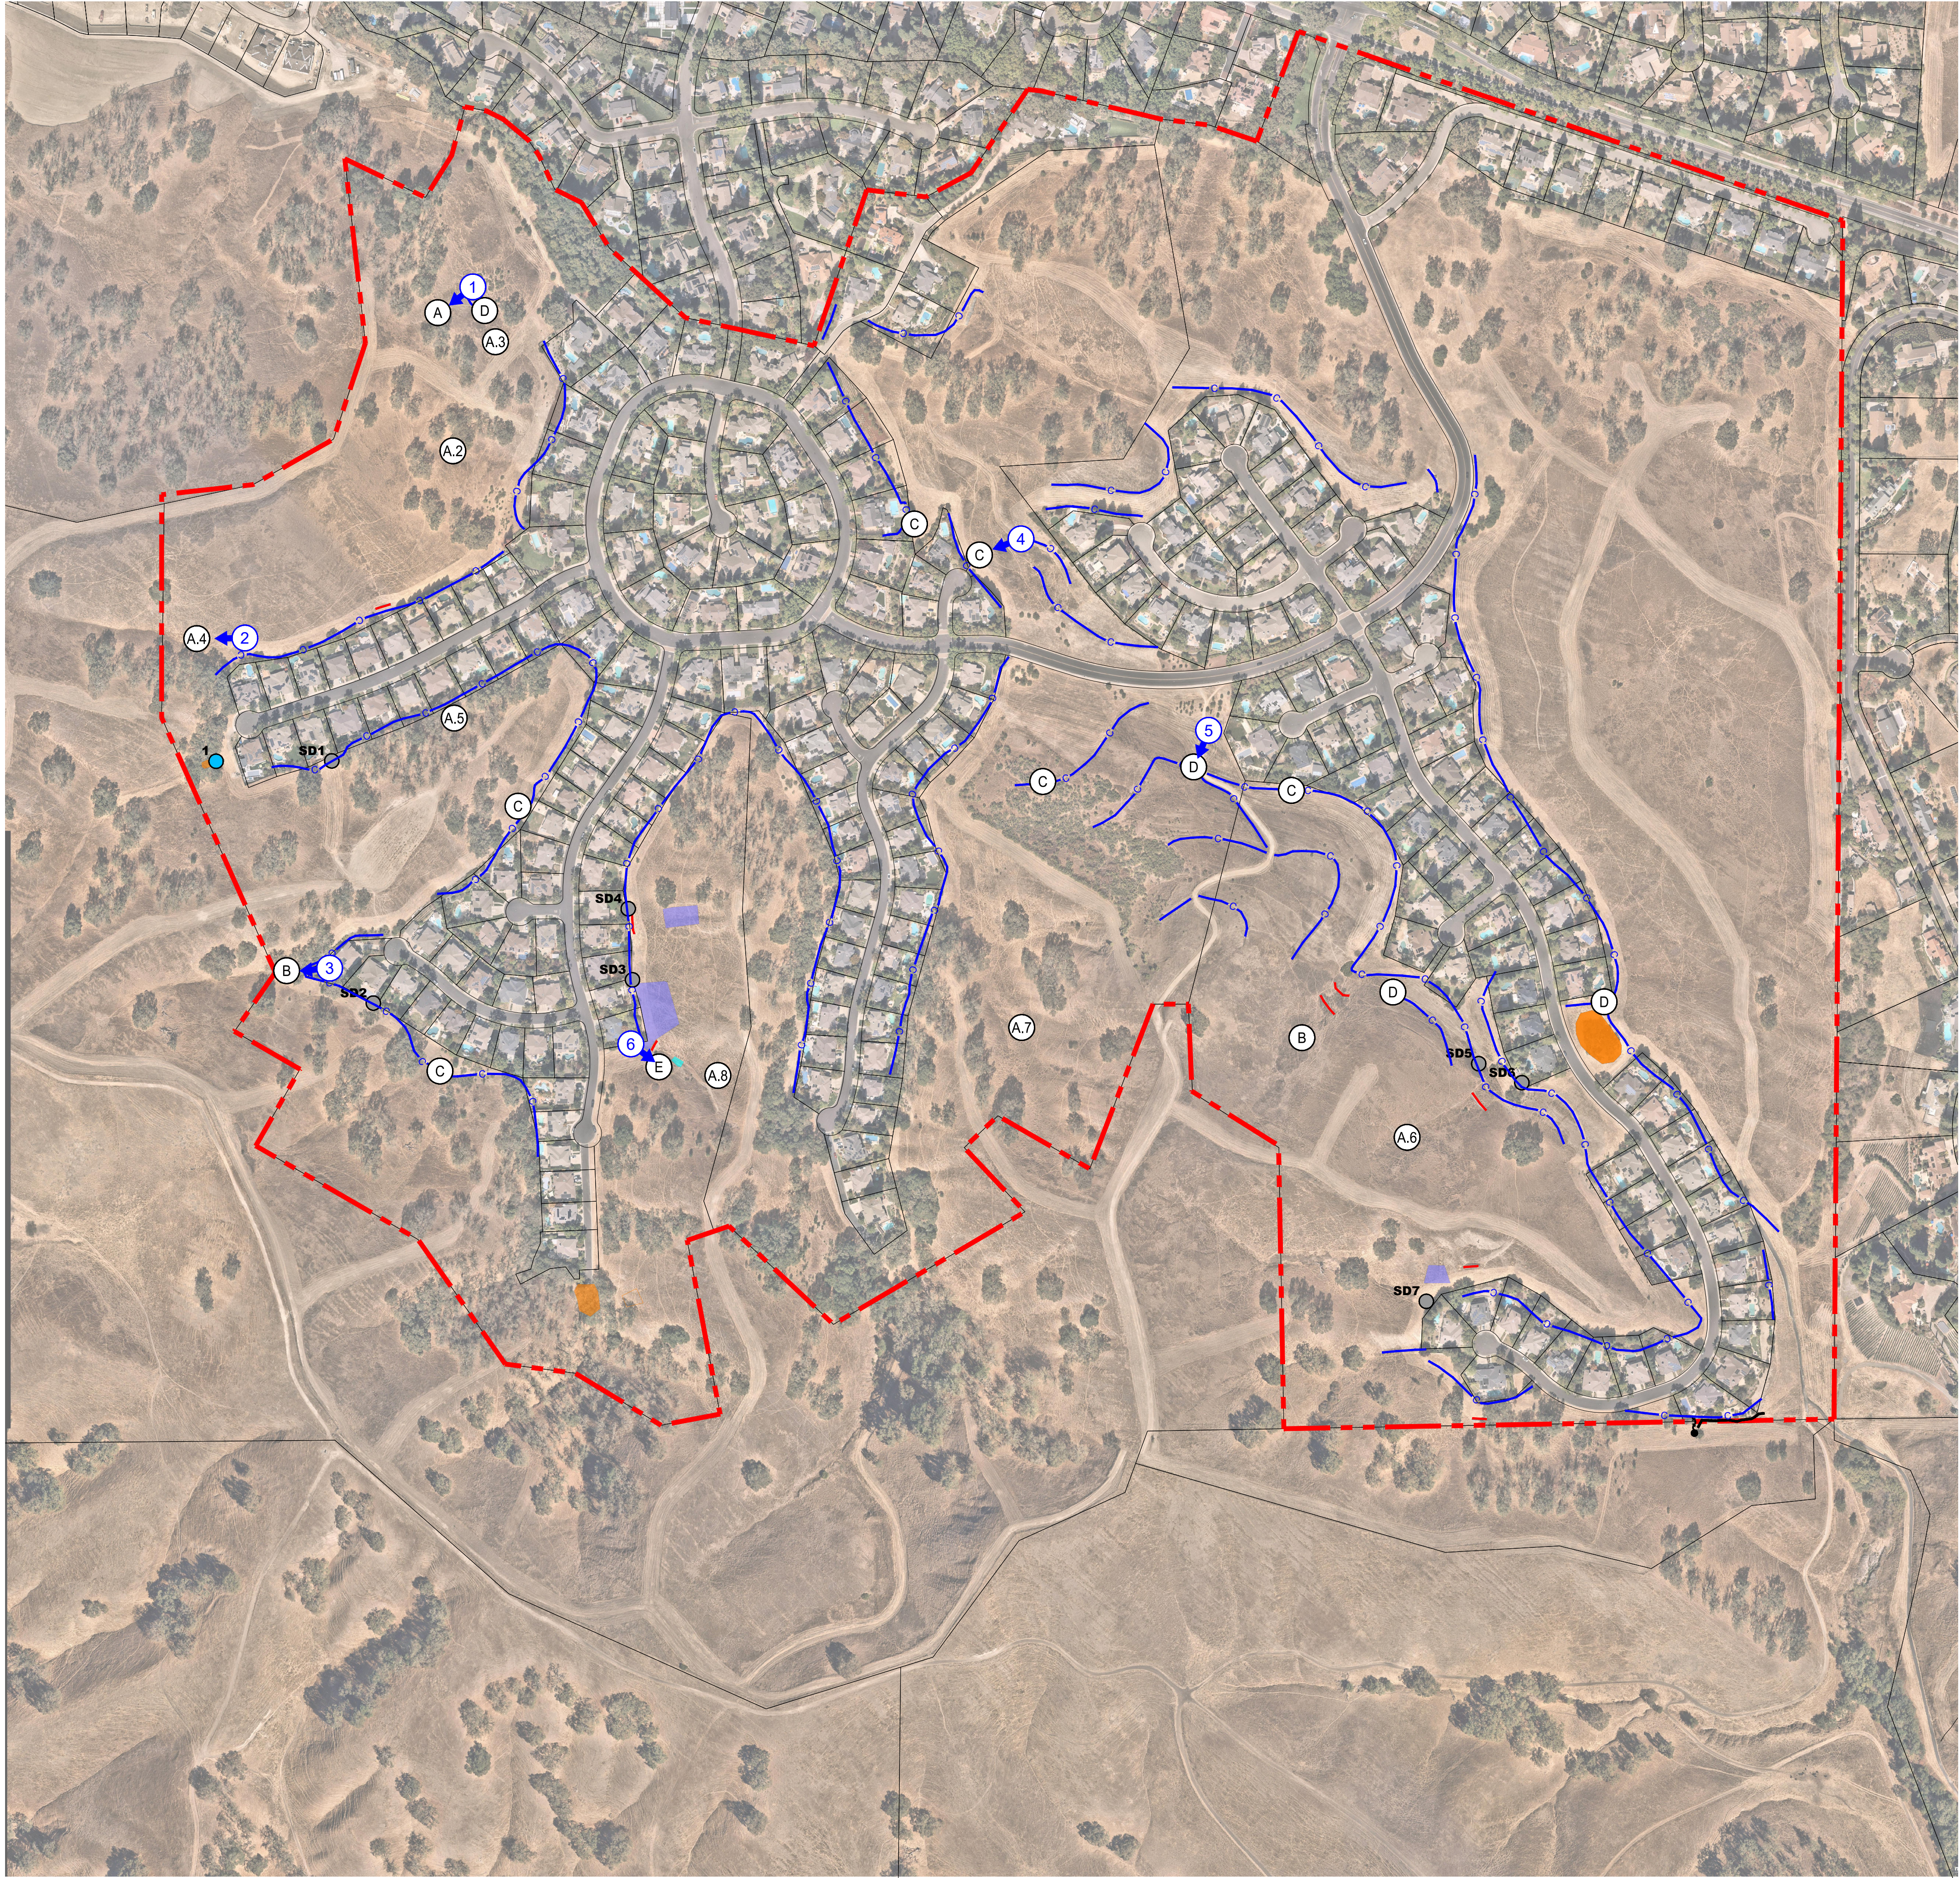
Slopes within the GHAD limits appeared to be performing well except for minor sloughing or shallow slides. The observed slope failures are limited in depth and extent or otherwise too far away from residences to be an immediate hazard (Figure 1, Table 1). We did not observe any indication of impending global failure within the project area.

Concrete-lined surface drainage ditches were viewed for evidence of sediment accumulation and distress, such as cracking or shifting. As shown in Figure 1, there are extensive concrete-lined drainage ditches within the GHAD-maintained parcels. The drainage ditches were variable in condition. The majority of drainage ditches observed appeared to be in good condition and free of debris. In some areas, we observed sediment accumulation or overgrowth in the ditch (Figure 1, Site Conditions C, Photograph 4). As part of the ongoing GHAD maintenance activities, debris will be removed from the drainage ditch. In the drainage ditch in the southeast portion of the site, we observed cracking and displacement within the concrete-lined ditch (Figure 1, Site Condition D, Photograph 5). Cracking should be covered over and repairs made to displaced ditches in order to restore proper flow to the channel.

We observed a number of storm drain outlets within the GHAD (Figure 1). In general, the subsurface drains located appeared to be in good order and free of obstructions and debris. We did not observe flow in any of the outlets. As we continue to monitor the site, additional or new subdrain outlets will be added to the monitoring report.
