CASE STUDY LAKE BOAT LAUNCH

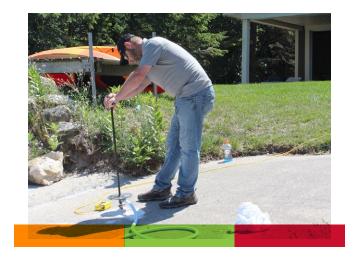
Located on a busy lake, this boat launch has survived many seasonal changes. Seasonal trends provide high and low water levels, storm surges and ice shoves. From the surface, this appears to be a private boat launch. However what you see is not the original boat launch slab. Under this visible slab is the original slab that had settled significantly and a new ramp was poured over top. For many years, waves have crashed onto the shore line and drained back into the lake. With every wave more and more soil was eroded. As the shoreline began to fail, it was built up with additional rip rap. These large rocks created a stronger barrier against the waves and ice, but did not prevent water from shedding down and under the slabs. The homeowner watched year after year as more shoreline eroded under the slabs. They knew the slab needed to be supported so they contacted FillFoam Canada for a solution.

FillFoam™ was installed under the boat launch slabs. This material was pumped as a flowable foam. Six holes were drilled through this thick three foot slab, around five feet apart. The crew started with filling the top of the boat launch and moved down towards the water. While pumping through the bottom drilled holes, air was escaping through the cracks at the bottom of the boat launch under water creating visible bubbles at the surface. While the FillFoam™ was pumped under the slab, the foam started flowing to the other drilled holes. This process continued until all the voids under the slabs were effectively filled.
