CASE STUDY

MIDWEST VOID FILL

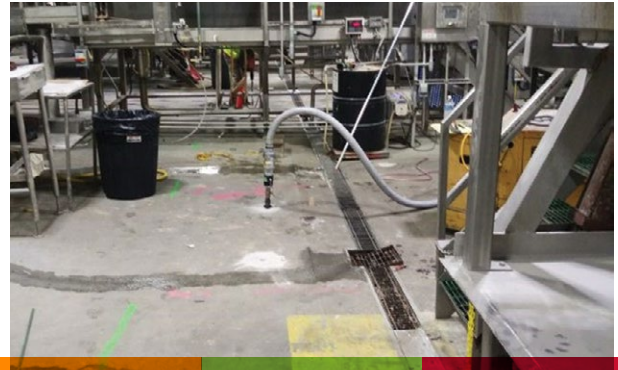
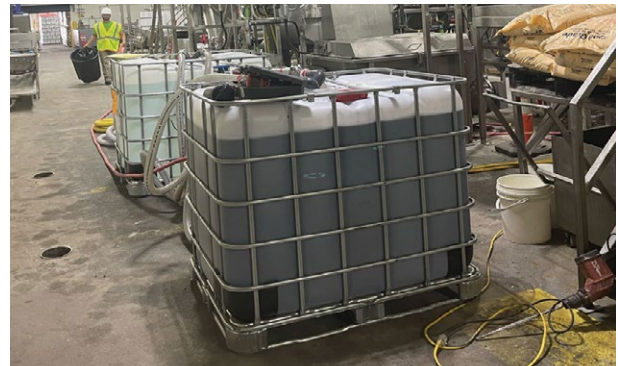
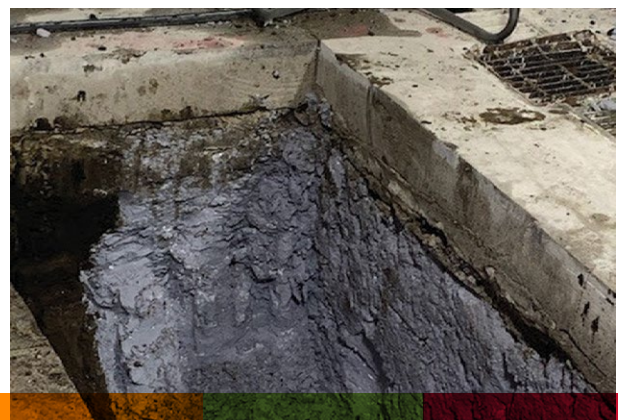
Prior to any repairs, the void needed to be filled to support the slab and the construction equipment needed to install the new drainage system. Voids were identified with GPR scan. Through two injection locations, 4,947 lbs of FillFoam material was installed, equaling a volume of 20 cubic yards. The complete void was pumped in 1 ½ hours. Within 24 hours a trench was dug through the cured foam to install new drainage pipes (picture below). Reinforced concrete was poured over the repair site and the plant was re-opened for operation.
