CASE STUDY

WAREHOUSE VOID FILL

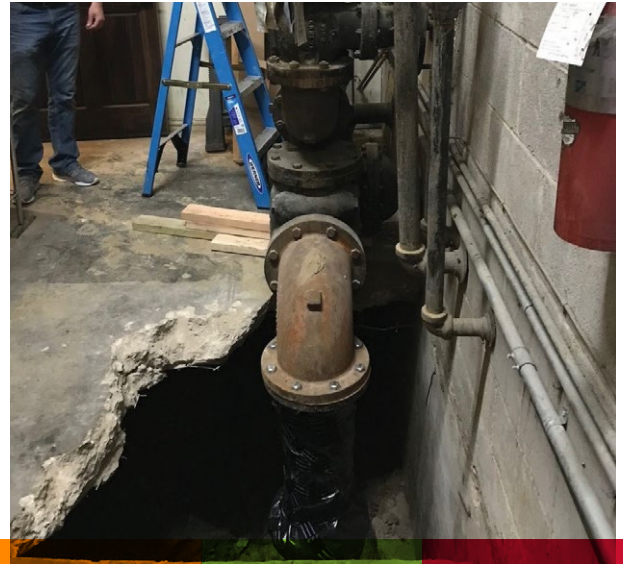
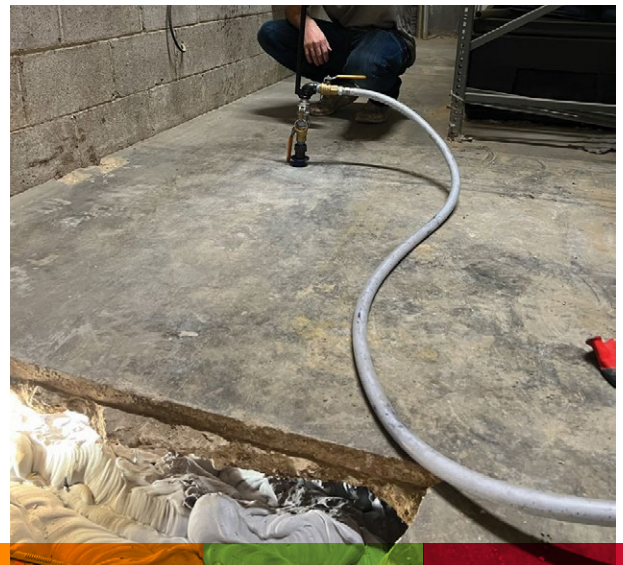
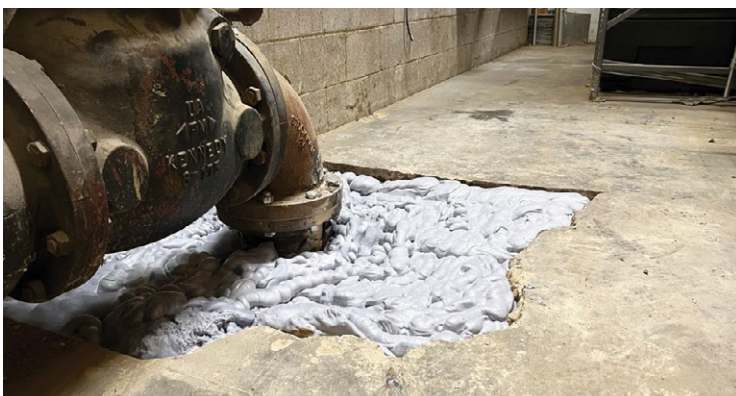
An interior floating slab had been compromised due to a fire riser break. The fire riser ruptured, and flooded out thousands of gallons of water under the slab and created a large void. The Fillfoam Canada contractor was contacted to evaluate the void.

The FillFoam Canada installer was awarded the job due to the quick and effective void filling solution. First, a portion of the slab was cut out while another portion was deemed salvageable by the engineering firm by use of the FillFoam installment. The installer strategically drilled 84 x 1" holes into the slab to insure proper coverage of the Fillfoam installed. The FillFoam was pumped quickly and safely with zero heat. FillFoam is the ideal choice for any void. It flowed easily to the deep crevice created.

This void was filled in just one day with 400 lbs. of FillFoam. After the void was filled, a layer of polyurethane foam was installed on top before the concrete was poured above.
