CASE STUDY

RESIDENTIAL POOL VOID FILL

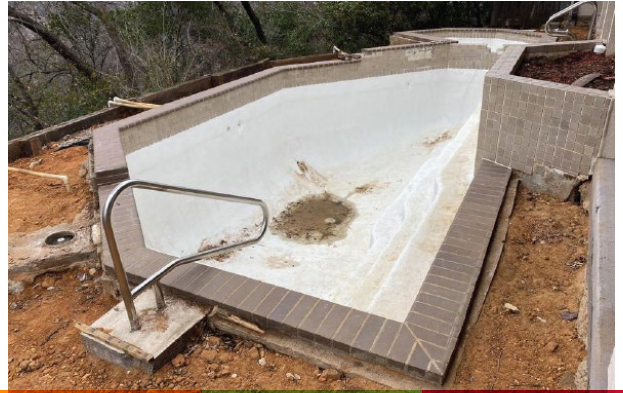
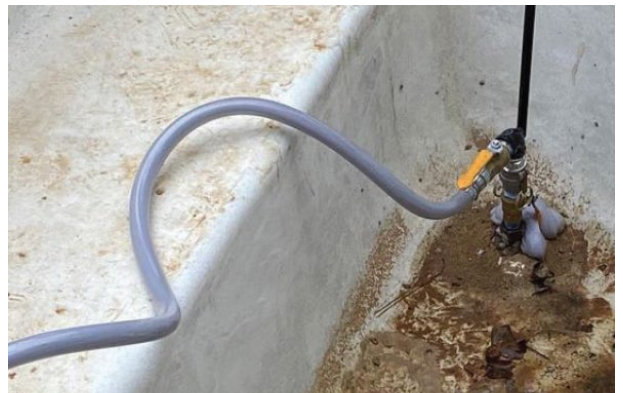
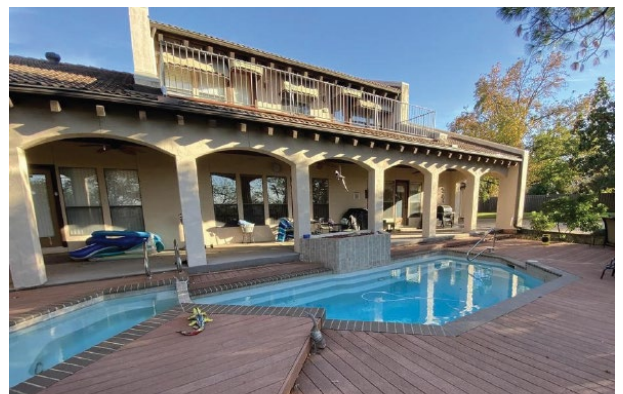
A 20 year old residential pool had settled around the entire perimeter upwards of 5 inches from end to end. This caused the skimmer pump to start sucking air and for the waterline to be off. The pool was located on the side of a hill and the soils began to erode, causing the “foundation” of the pool to shift. A common problem for structures built on hillsides.

FillFoam Canada was contracted to stabilize the pool. They first installed steel piers under the entirety of the pool to achieve the necessary lift. Next, they strategically drilled five 1-inch holes through the shell of the pool. They then installed 4 cubic yards of FillFoam™ to fill the void created during the lift. By using FillFoam™, they were able to ensure that the void was completely filled using a minimal amount of holes. FillFoam™ is a two-part mixture of a resin and hardener, and was chosen for this project because it does not lift and can flow hundreds of feet from the injection point. This process was important to stabilize the pool before further erosion could occur and to prevent costly repairs.
