CASE STUDY

PARKING LOT VOID FILL

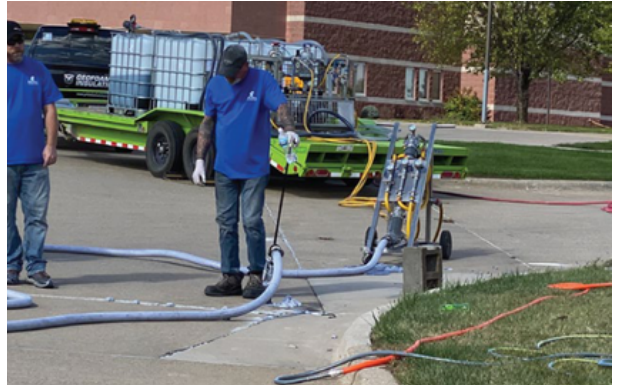
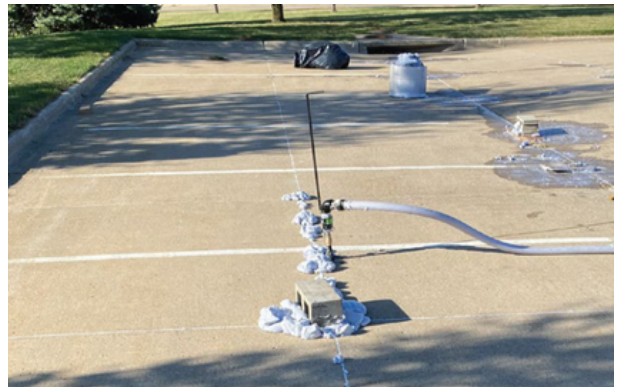
This church has had drainage challenges since construction. Water shedding off of the building would flow under the slab as it traveled to the drainage system. This created a channel for water to flow under the slab. Years of water flowing through this channel eroded the soils supporting the parking lot. Within the past 15 years the congregation elected to mudjack the void to support the slabs. Eventually the problem did arise again as the mudjacking grout eroded like the original soils, this time assisted by a leaking fire hydrant and sprinkler system. Seeking a more permanent solution, the congregation contacted a local contractor for other options.

FillFoam was installed under the voided slab. The depth of voids ranged from 2-18", additionally there were up to 4 feet of weak soils below the slabs. The majority of the holes used to inject FillFoam under the slab were from the previous installation of mudjacking material. This provided a 10 foot grid pattern. Foam was pumped under the slab until it started to come up through adjacent holes and along the joints between slabs. The holes were then plugged and more foam was installed. This allowed the foam to build pressure and flow further. It also helped compact the loose soils and fill the voids under the slabs. Foam will travel the path of least resistance. Foam will not travel out other cracks, joints or holes until enough foam has been installed to build pressure and push out past the slab.

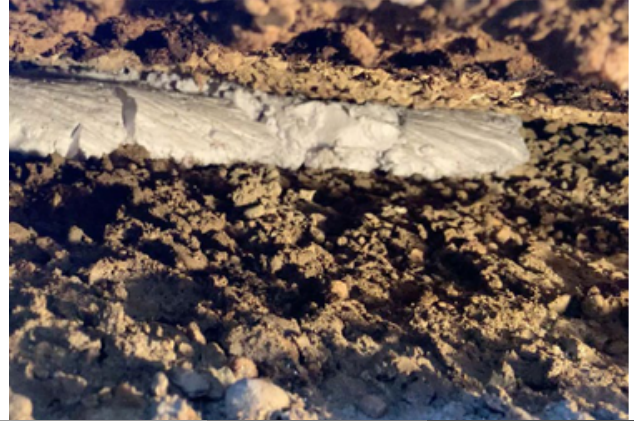
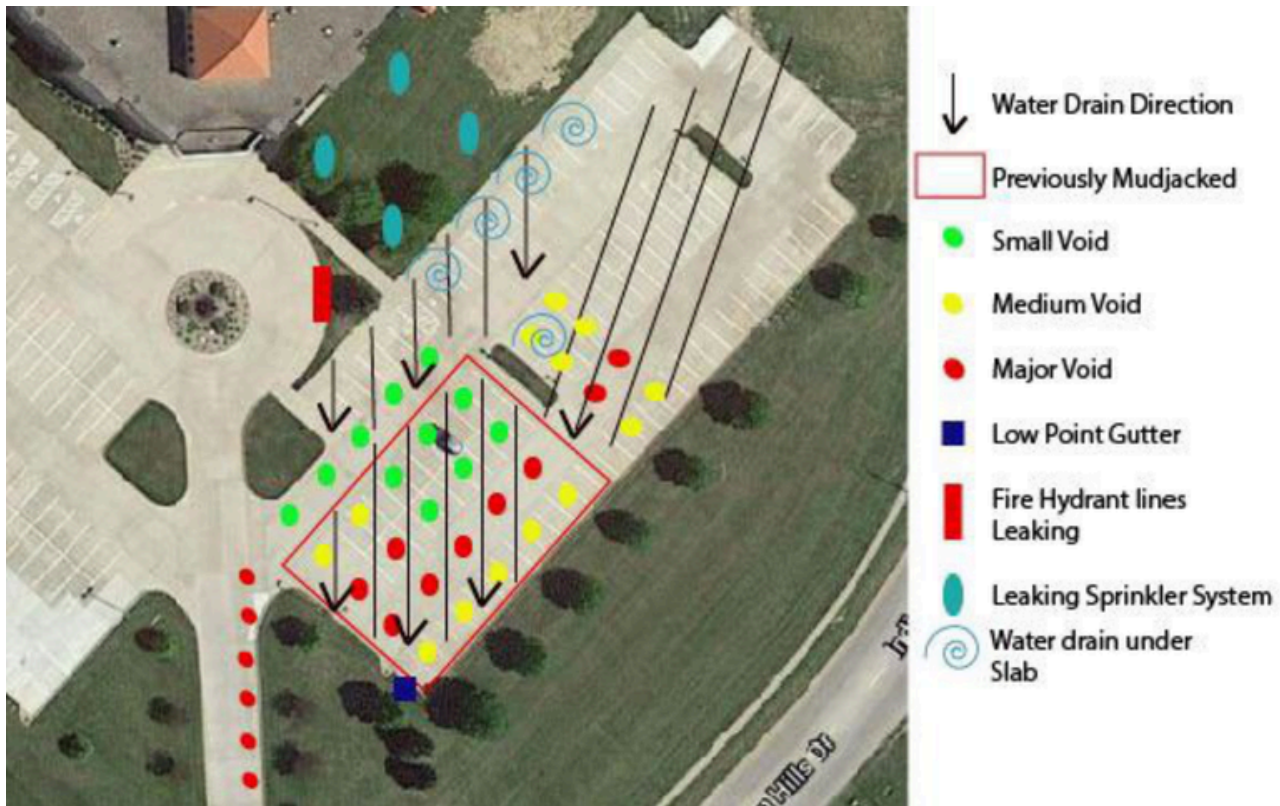
68 cubic yards of FillFoam were installed under the parking lot to support the slab. This job was completed within 8 hours with the Hi-Volume FillFoam System. The Church group can now be confident that the material supporting their parking lot will not wash away or interfere with drainage.
