CASE STUDY

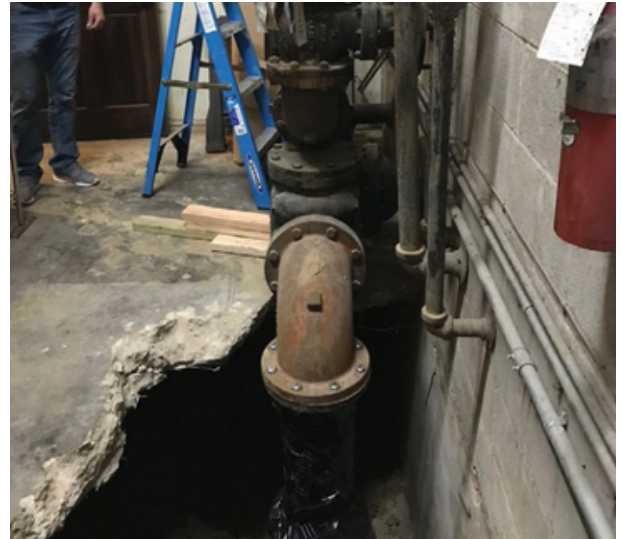
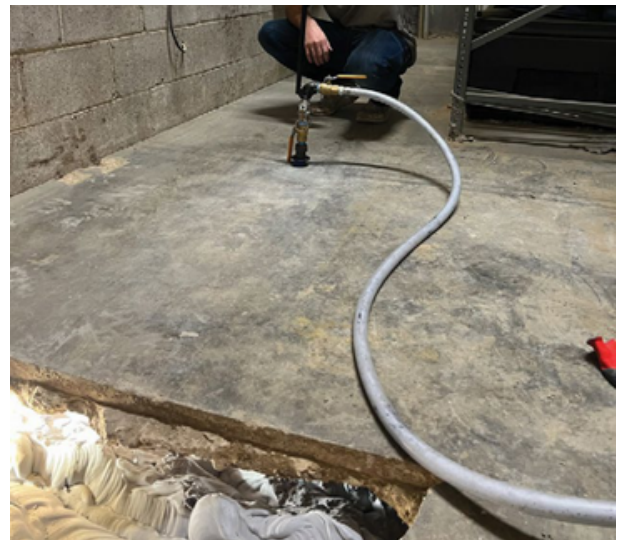
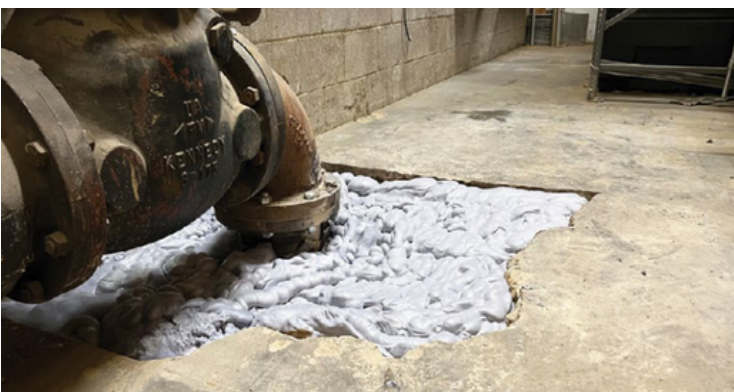
An interior floating slab had been compromised due to a fire riser break. The fire riser ruptured, and flooded out thousands of gallons of water under the slab and created a large void. ECO Fillfoam was contacted to evaluate the void.

ECO FillFoam was awarded the job due to the quick and effective void filling solution. First, a portion of the slab was cut out while another portion was deemed salvageable by the engineering firm by use of the FillFoam installment. The installer strategically drilled 84 x 1" holes into the slab to insure proper coverage of the Fillfoam installed. The FillFoam was pumped quickly and safely with zero heat. FillFoam is the ideal choice for any void. It flowed easily to the deep crevice created.

This void was filled in just one day with 400 lbs. of FillFoam. After the void was filled, a layer of polyurethane foam was installed on top before the concrete was poured above.
