CASE STUDY

RESIDENTIAL POOL VOID FILL

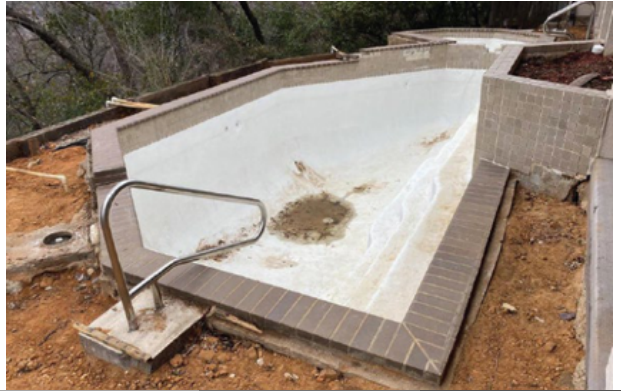
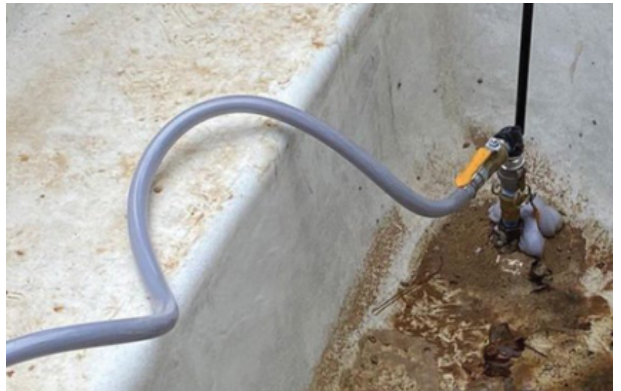
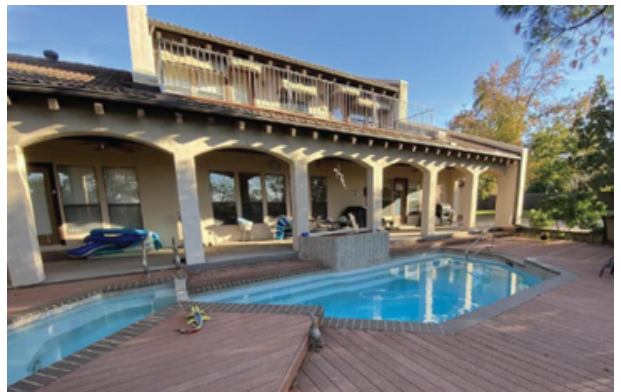
A 20 year old residential pool had settled around the entire perimeter upwards of 5 inches from end to end. This caused the skimmer pump to start sucking air and for the waterline to be off. The pool was located on the side of a hill and the soils began to erode, causing the "foundation" of the pool to shift. A common problem for structures built on hillsides.

ECO FillFoam was contracted to stabilize the pool. They first installed steel piers under the entirety of the pool to achieve the necessary lift. Next, they strategically drilled five 1-inch holes through the shell of the pool. They then installed 4 cubic yards of FillFoam™ to fill the void created during the lift. By using FillFoam™, they were able to ensure that the void was completely filled using a minimal amount of holes. FillFoam™ is a two-part mixture of a resin and hardener, and was chosen for this project because it does not lift and can flow hundreds of feet from the injection point. This process was important to stabilize the pool before further erosion could occur and to prevent costly repairs.
