### CASE STUDY - FOUNDATION CRACK INJECTION

Telecommunication company in Yorkton, SK

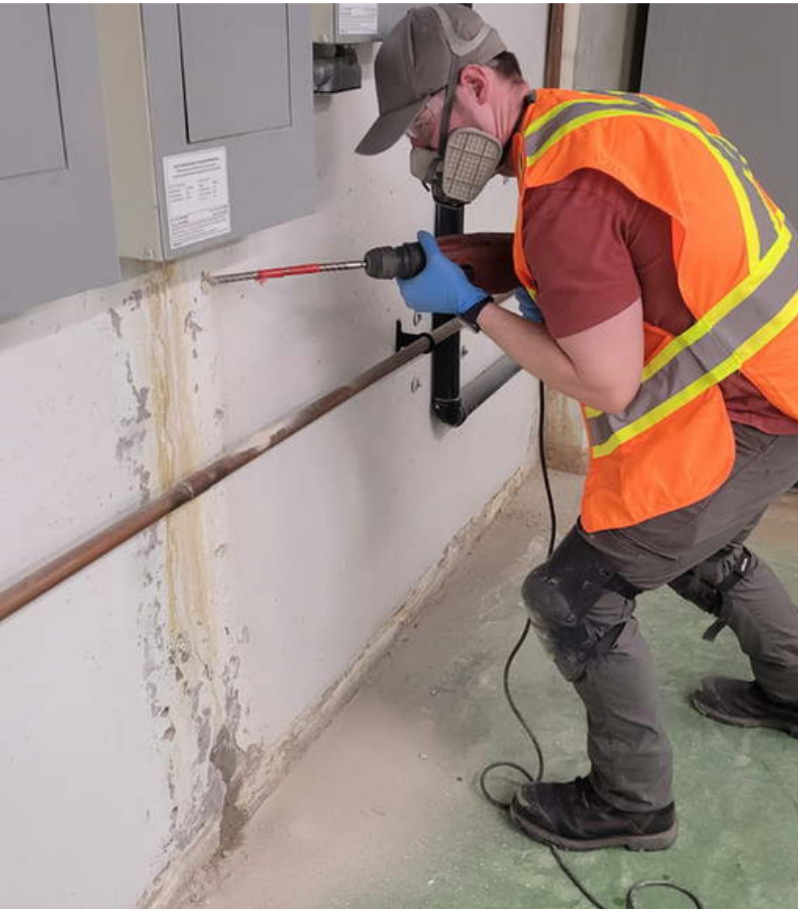
A switching station, owned by a telecommunication company, located in Yorkton Sk. was experiencing persistent water seepage through multiple thin cracks in the foundation walls. The various sized cracks had gradually worsened over time, allowing moisture intrusion in areas throughout the lower level filled with electronic equipment and communication lines. Due to excessive costs, traditional repair methods from the exterior were not an option. The company Engineer sought a permanent, minimally invasive solution to stop water infiltration and protect the lower level.

Eco Seal proposed Acrylate Grout Injection, an ideal solution for sealing hairline cracks in below-grade structures. The acrylate grout's low viscosity allowed it to penetrate deep into the crack, ensuring a watertight seal. The project followed a precise six-step injection process:
