### CASE STUDY - FOUNDATION CRACK INJECTION

Commercial - Large Regina School

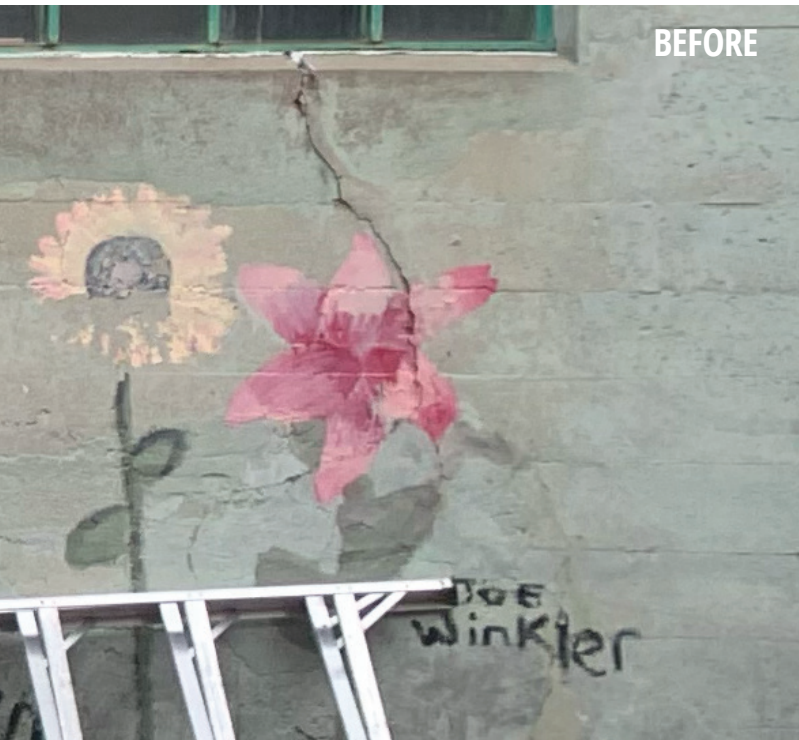
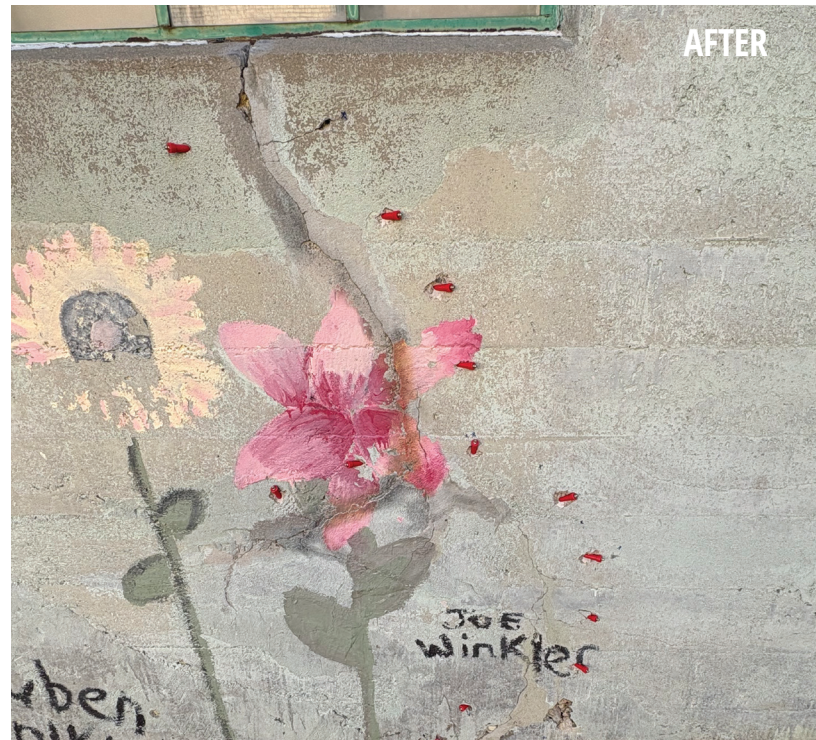
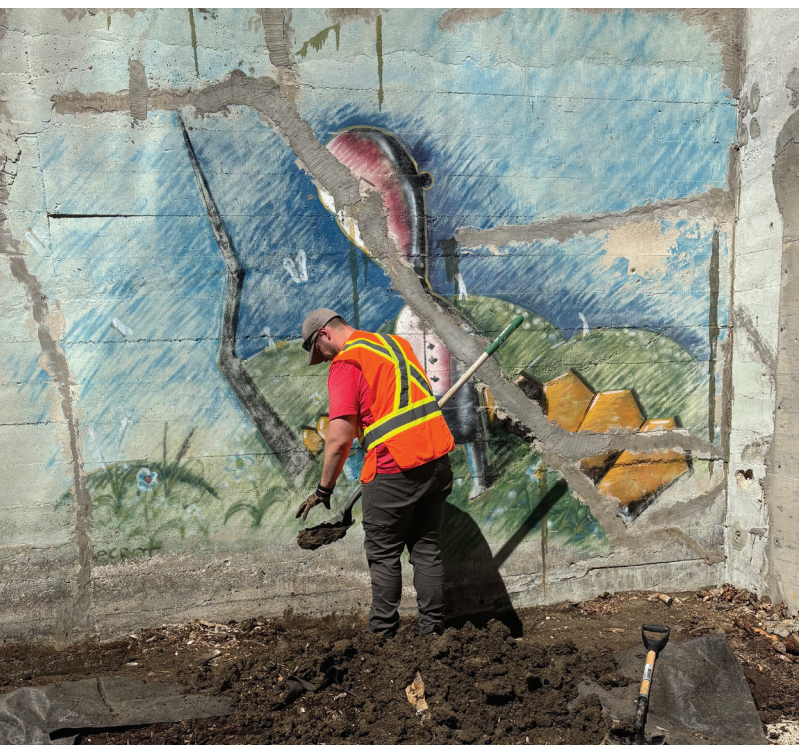
Water seepage from multiple large and worsening cracks in the foundation walls plagued a large school within the Regina Public School System. Moisture infiltrated various areas, notably the library. Traditional repair methods were not feasible because interior rooms were finished and classrooms occupied. The Regina Public Schools maintenance team sought a permanent, minimally invasive solution to halt water intrusion and safeguard the lower level.

Eco Seal suggested using a one-part polyurethane sealant to effectively seal cracks throughout the structure. The sealant's thin consistency enabled thorough penetration into the cracks, creating a waterproof barrier. The application involved a detailed six-step injection procedure.

1. **Drilling:** Small-diameter holes were strategically drilled along the crack to intercept it and allow injection points.
2. **Injection Port Installation & Water Testing:** Ports were installed at drilled points and tested with water and cleansed with muriatic acid to confirm crack interception and flow paths.

3. **Injector Ports & Sealing:** The surface of the crack was sealed with hydraulic cement to contain the injection.
4. **Mixing & Testing:** The polyurethane sealant components were mixed, and small test batches were used to confirm reaction times and ensure optimal formation.

5. **Injection & Solidification:** Using a pump, the polyurethane sealant was injected, filling the entire crack from bottom to top, penetrating tight spaces, and forming a flexible, water-tight seal.

6. **Port Removal & Patching:** Once the sealant was fully cured, the ports were removed, and the drilled holes were patched for a clean, finished appearance.
