Magee Ranch
HOA
Danville , CA

Report #: 20912-12
Beginning: January 1, 2024
Expires: December 31, 2024

RESERVE STUDY
Update "With-Site-Visit"

September 13, 2023

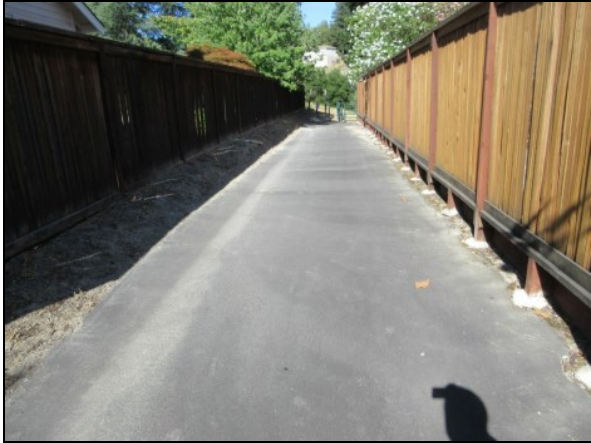
Comp #: 203 Fire Road - Seal/Repair

Useful Life:
5 years

Remaining Life:
0 years

Best Case: \$ 70,000

Worst Case: \$ 90,000

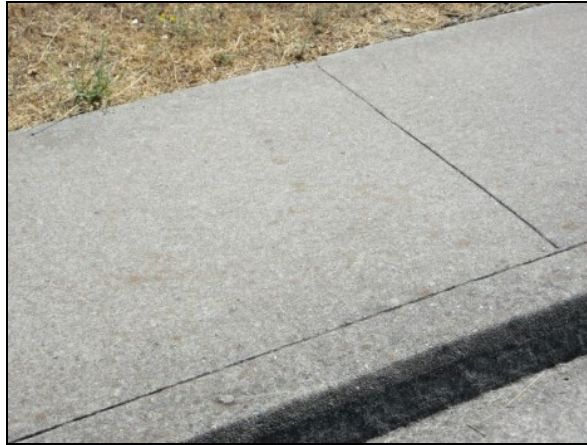
Comp #: 211 Concrete - Repair

Useful Life:
5 years

Remaining Life:
0 years

Best Case: \$ 6,000

Worst Case: \$ 8,000

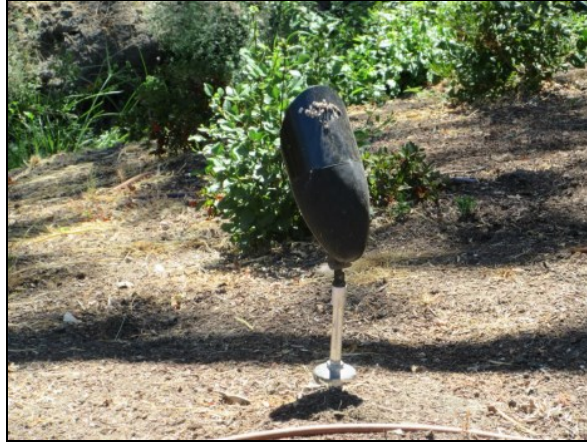
Comp #: 321 Ground Lights - Replace (25%)

Useful Life:
5 years

Remaining Life:
3 years

Best Case: \$ 15,000

Worst Case: \$ 17,000

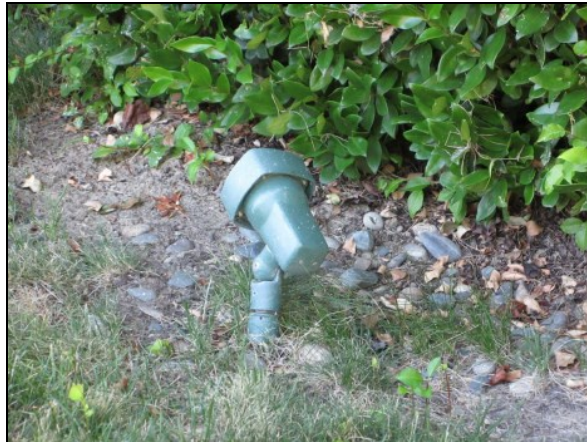
Comp #: 331 Entry Lights - Replace

Useful Life:
15 years

Remaining Life:
13 years

Best Case: \$ 21,000

Worst Case: \$ 23,000
