**Magee Ranch**  
**HOA**  
***Danville , CA***

Report #: 20912-13  
Beginning: January 1, 2025  
Expires: December 31, 2025

**RESERVE STUDY**  
**Update "No-Site-Visit"**

July 11, 2024

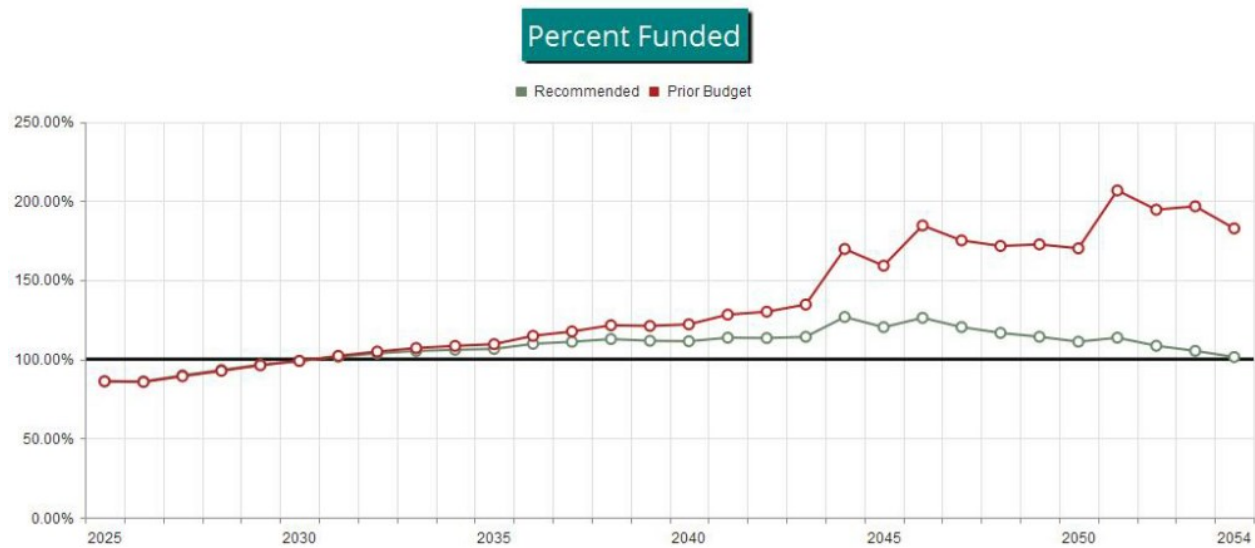
Figure 4

This figure shows the same information plotted on a Percent Funded scale. It is clear here to see how your Reserve Fund strength approaches the 100% Funded level under our recommended multi-yr Funding Plan.
