**FILLFOAM**  
C A N A D A

# CASE STUDY

## RAILROAD CULVERT FILL

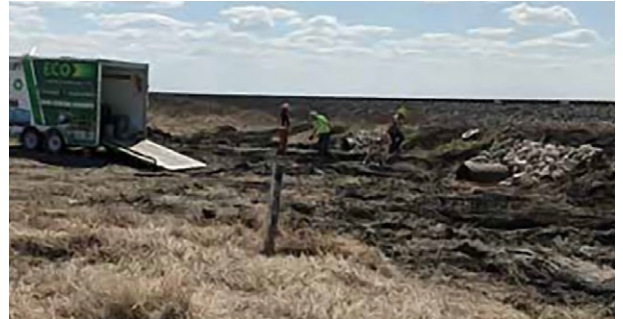
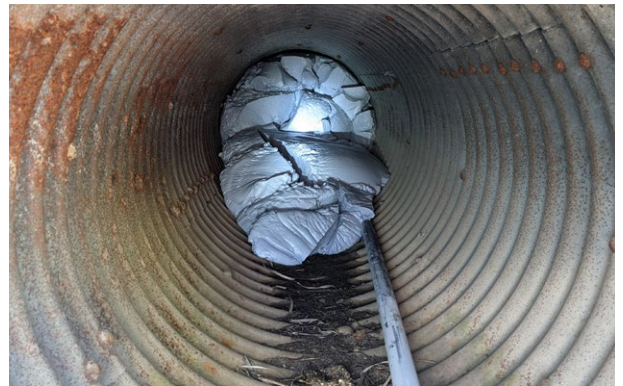
FillFoam Canada was approached by a Canadian rail company to assist with the abandonment of old culverts running under their railways. Old culverts were made of corrugated steel which had begun to fail in certain locations under the tracks. The client wished to fill these culverts to reinforce the structure ensuring the ground above them would not collapse in the future. They also needed to ensure that water was not able to flow through and continue to erode areas that were already failing. Once these culverts were filled, the ends would be crushed and buried into the railway embankment. Client concerns included the following: Traditional methods were time consuming, expensive, and complicated. Traditional abandonment products were not eco friendly and posed challenges during installation. For example, concrete slurry mixtures would “blow out” during installation, requiring a major cleanup operation. They also require heavy equipment which, when operating beside highways, would require extra resources for traffic control, lane closures and other safety measures.

FillFoam Canada presented a solution to the client that would provide all the benefits with none of the risks or complications. FillFoam Canada built a 50 ft injection nozzle and capped the far end of the culvert leaving a single exhaust port. The 50 ft nozzle was placed into the 75 ft culvert creating an injection point 25 ft from the end. Foam was pumped in from this point until it pressurized the far end and began coming out of the port. The port was then plugged, and the nozzle was pulled roughly 10 ft back towards the open end of the culvert. Each time the foam moved 10-15 ft back towards the injection end

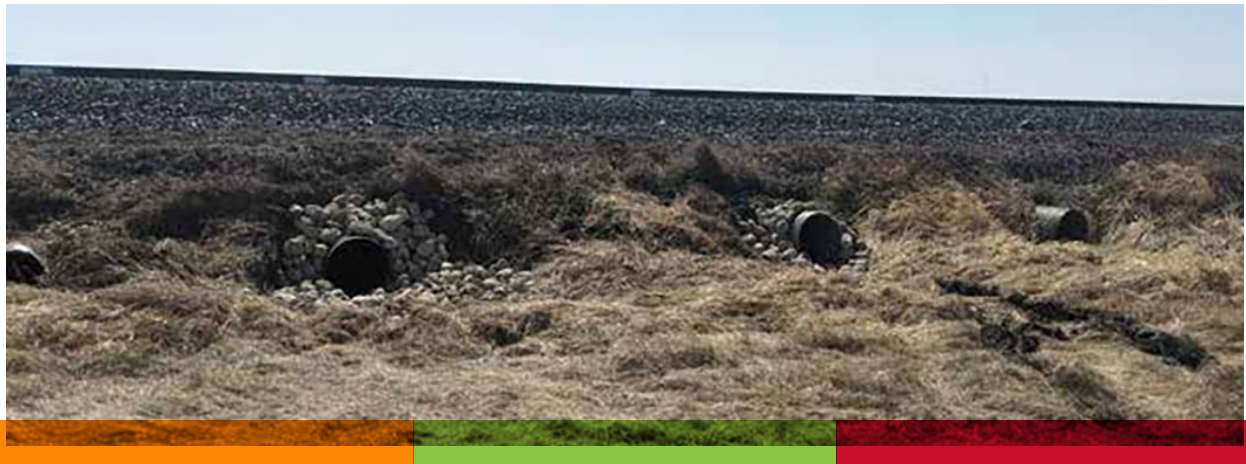
of the culvert, the nozzle was pulled back as well. Keeping roughly 10 ft of foam between the open end (injection side) of the culvert and the end of the nozzle. This approach kept the foam under positive pressure during installation allowing it to fill to the volume of the culvert. Once the foam reached the injection side of the culvert, the nozzle was slowly removed while the pumps were still running to ensure that any void left behind was filled. Once removed, the pumps were shut down. This process took roughly 2 hours per culvert.

FillFoam Canada's approach removed the heavy equipment requirements, as the only equipment required onsite was a  $\frac{3}{4}$  ton truck and trailer. This eliminated the need to shut down one lane of the highway and manage traffic as equipment was moved or operated. This approach also eliminated concerns related to spills. The cleanup of concrete slurry is a much more involved process as the product is highly flowable and often a leak leads to many yards of liquid concrete spilling into potentially sensitive areas. Fillfoam cleanup is extremely fast, safe, and efficient.
