**FILLFOAM**  
C A N A D A

# CASE STUDY

## RESIDENTIAL VOID FILL

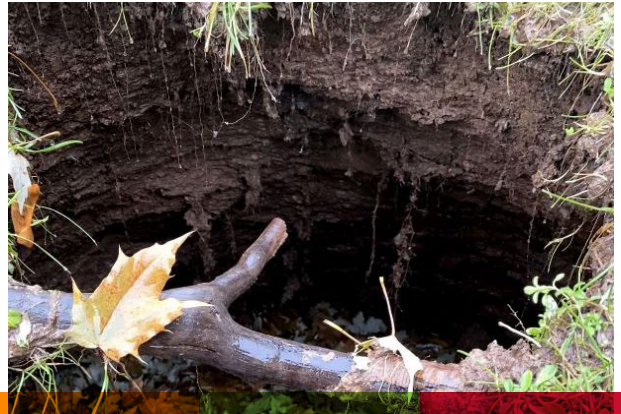
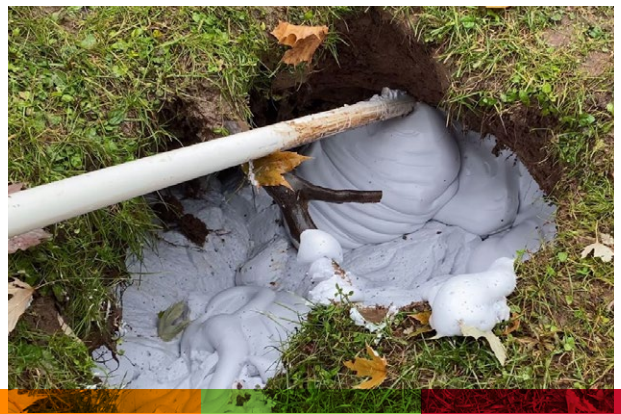
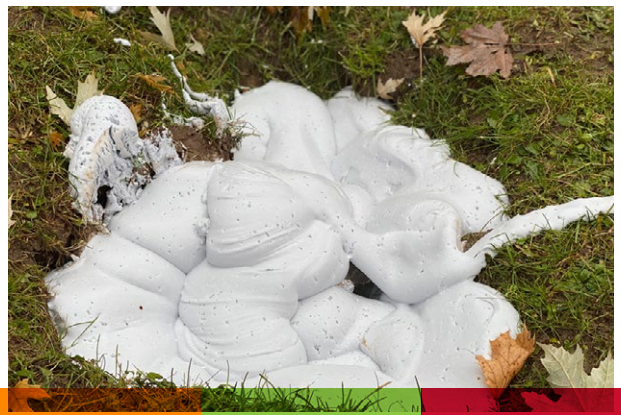
A homeowner was cleaning up his yard in late November of 2019 when the back tire of his lawn tractor got stuck. Puzzled, the homeowner freed his lawn tractor and discovered that he had a large sinkhole in his yard. The hole had an opening that was roughly three feet in diameter and expanded to about a six foot diameter at the bottom of the hole and was about five feet deep. The homeowner was confused as to how a sinkhole would have developed in his yard since he lived right in the city. He contacted the city's public works department who came out to his house and determined that the hole was not caused by ruptured water lines, which could have caused a washout, or by an abandoned culvert.

Unsure of what to do with the hole and concerns about its potential impact on his home's foundation, the customer contacted FillFoam on a Friday afternoon. A representative from FillFoam was at his home the very next Monday to inspect the area to see if the sinkhole could be addressed. Sinkholes in the area are often caused by limestone or dolomite in the ground. Limestone and dolomite are rocks that are easily fractured and can dissolve in water. Water seeping down beneath the soil can cause erosion in the limestone or dolomite, which can lead to underground cavities developing. Water will flow into these underground cavities taking the surface soil with it, which in turn will cause a sinkhole. The summer and fall of 2019 had a large amount of rain in the area, which is believed to have aided in the development of this particular sinkhole.

After observing the sinkhole and researching sinkholes in the area, the customer was contacted and a plan to address the sinkhole was proposed to the customer on Tuesday, the very next day. Because the sinkhole was smaller and far enough away from the customer's home, the plan was to fill the sinkhole with FillRite Technologies FillFoam and monitor the area. FillFoam is a flowable fill foam engineered for large cavity and void filling. After the hole was filled, the area was observed over the upcoming winter and following spring to see if further action was required. At that point, if continued settling of the area occurred, Deep Foamjection™ process would have been required to stabilize the soil. Deep Foamjection™ is the process of injecting high density foam deep into soils to bind the soil and give soft soils stability.

The low-cost of the FillFoam option made it an easy choice for the customer and the sinkhole was filled by pumping 278 lbs. of FillFoam into. Once the hole was filled, topsoil was placed over the top of the FillFoam. Total time of project from arrival to clean-up was just under one hour.
