# CASE STUDY

## RAILROAD CULVERT FILL

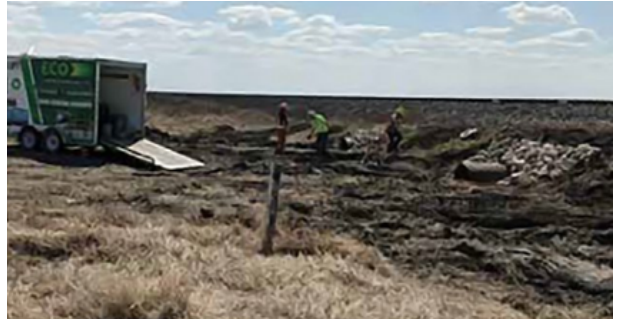
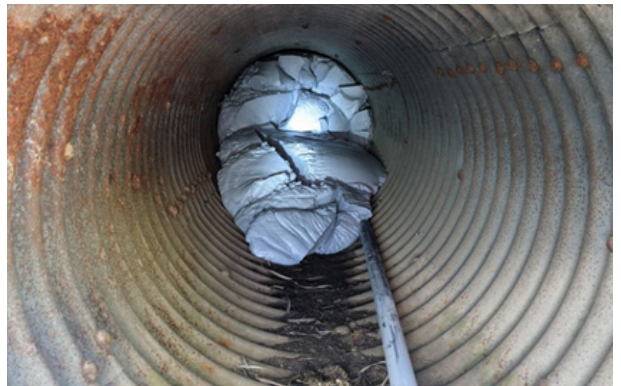
FillFoam Canada was approached by a Canadian rail company to assist with the abandonment of old culverts running under their railways. Old culverts were made of corrugated steel which had begun to fail in certain locations under the tracks. The client wished to fill these culverts to reinforce the structure ensuring the ground above them would not collapse in the future. They also needed to ensure that water was not able to flow through and continue to erode areas that were already failing. Once these culverts were filled, the ends would be crushed and buried into the railway embankment. Client concerns included the following: Traditional methods were time consuming, expensive, and complicated. Traditional abandonment products were not eco friendly and posed challenges during installation. For example, concrete slurry mixtures would “blow out” during installation, requiring a major cleanup operation. They also require heavy equipment which, when operating beside highways, would require extra resources for traffic control, lane closures and other safety measures.

FillFoam Canada presented a solution to the client that would provide all the benefits with none of the risks or complications. FillFoam Canada built a 50 ft injection nozzle and capped the far end of the culvert leaving a single exhaust port. The 50 ft nozzle was placed into the 75 ft culvert creating an injection point 25 ft from the end. Foam was pumped in from this point until it pressurized the far end and began coming out of the port. The port was then plugged, and the nozzle was pulled roughly 10 ft back towards the open end of the culvert. Each time the foam moved 10-15 ft back towards the injection end
