CASE STUDY

Problem

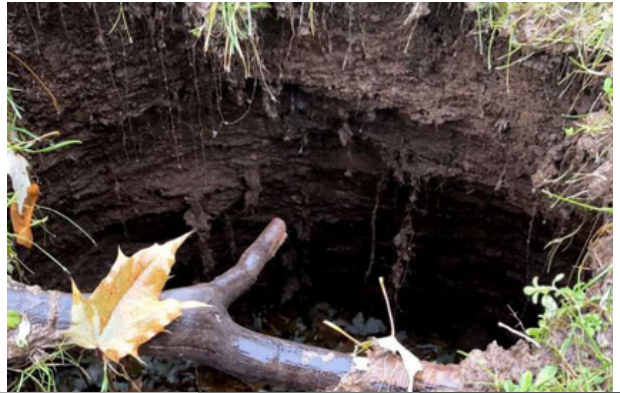
A homeowner was cleaning up his yard in late November of 2019 when the back tire of his lawn tractor got stuck. Puzzled, the homeowner freed his lawn tractor and discovered that he had a large sinkhole in his yard. The hole had an opening that was roughly three feet in diameter and expanded to about a six foot diameter at the bottom of the hole and was about five feet deep. The homeowner was confused as to how a sinkhole would have developed in his yard since he lived right in the city. He contacted the city's public works department who came out to his house and determined that the hole was not caused by ruptured water lines, which could have caused a washout, or by an abandoned culvert.

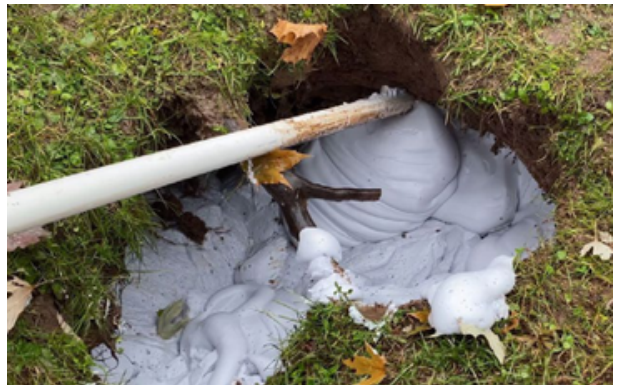
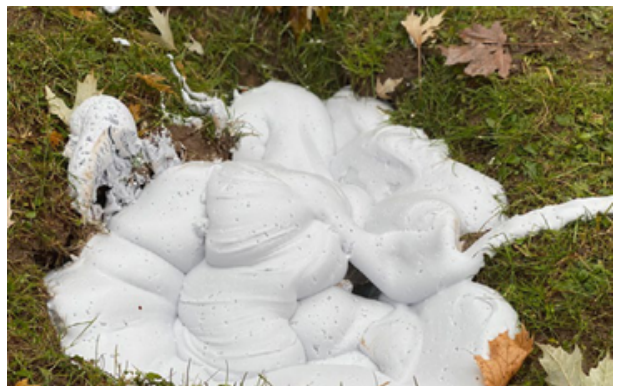
Unsure of what to do with the hole and concerns about its potential impact on his home's foundation, the customer contacted ECO FillFoam on a Friday afternoon. A representative from ECO FillFoam was at his home the very next Monday to inspect the area to see if the sinkhole could be addressed. Sinkholes in the area are often caused by limestone or dolomite in the ground. Limestone and dolomite are rocks that are easily fractured and can dissolve in water. Water seeping down beneath the soil can cause erosion in the limestone or dolomite, which can lead to underground cavities developing. Water will flow into these underground cavities taking the surface soil with it, which in turn will cause a sinkhole. The summer and fall of 2019 had a large amount of rain in the area, which is believed to have aided in the development of this particular sinkhole.

After observing the sinkhole and researching sinkholes in the area, the customer was contacted and a plan to address the sinkhole was proposed to the customer on Tuesday, the very next day. Because the sinkhole was smaller and far enough away from the customer's home, the plan was to fill the sinkhole with FillRite Technologies FillFoam and monitor the area. FillFoam is a flowable fill foam engineered for large cavity and void filling. After the hole was filled, the area was observed over the upcoming winter and following spring to see if further action was required. At that point, if continued settling of the area occurred, Deep Foamjection™ process would have been required to stabilize the soil. Deep Foamjection™ is the process of injecting high density foam deep into soils to bind the soil and give soft soils stability.
