CASE STUDY - FOUNDATION WATER SEEPAGE INJECTION REPAIR

Residential home in Regina, SK

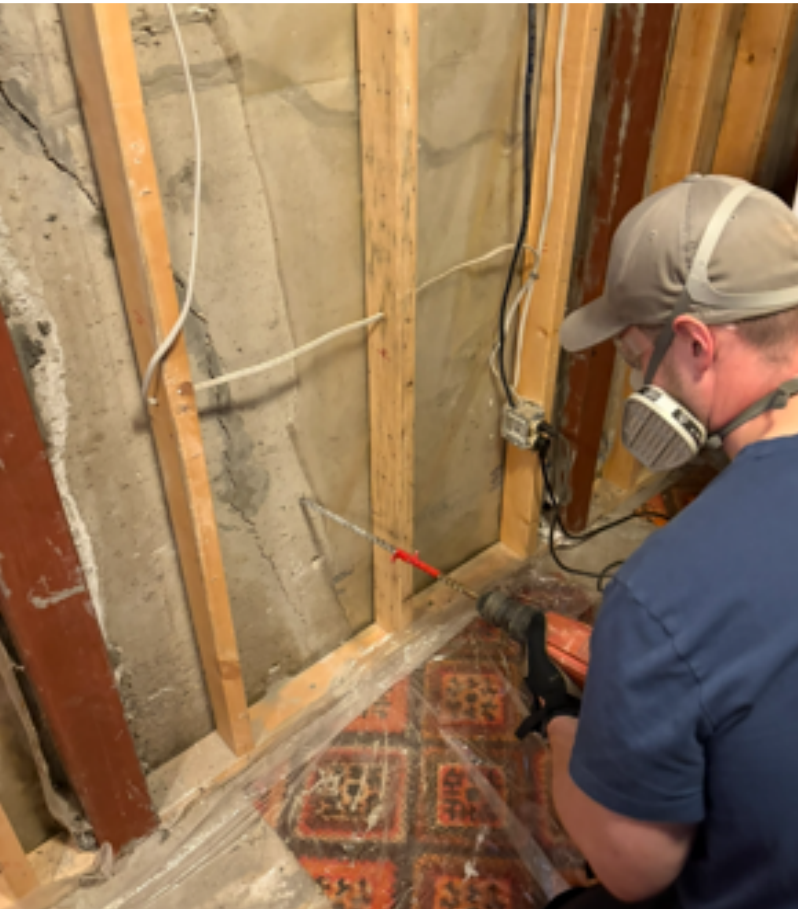
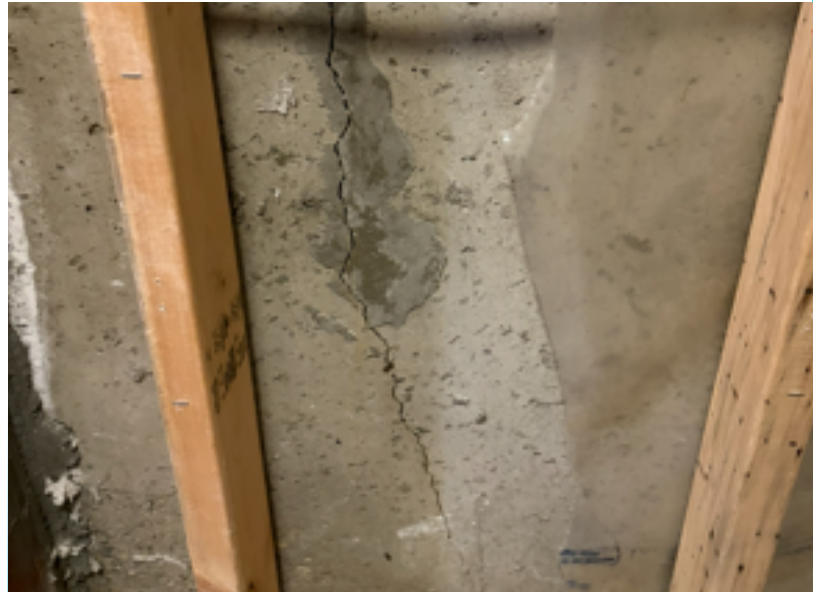
A young couple recently purchased a starter home in Regina Sk and were concerned about a large crack in its foundation wall, causing persistent water seepage and subsequent interior water damage. Exterior repairs were deemed too expensive. The homeowner required a long-lasting, non-invasive method to eliminate water infiltration and safeguard the basement before completing their basement renovation.

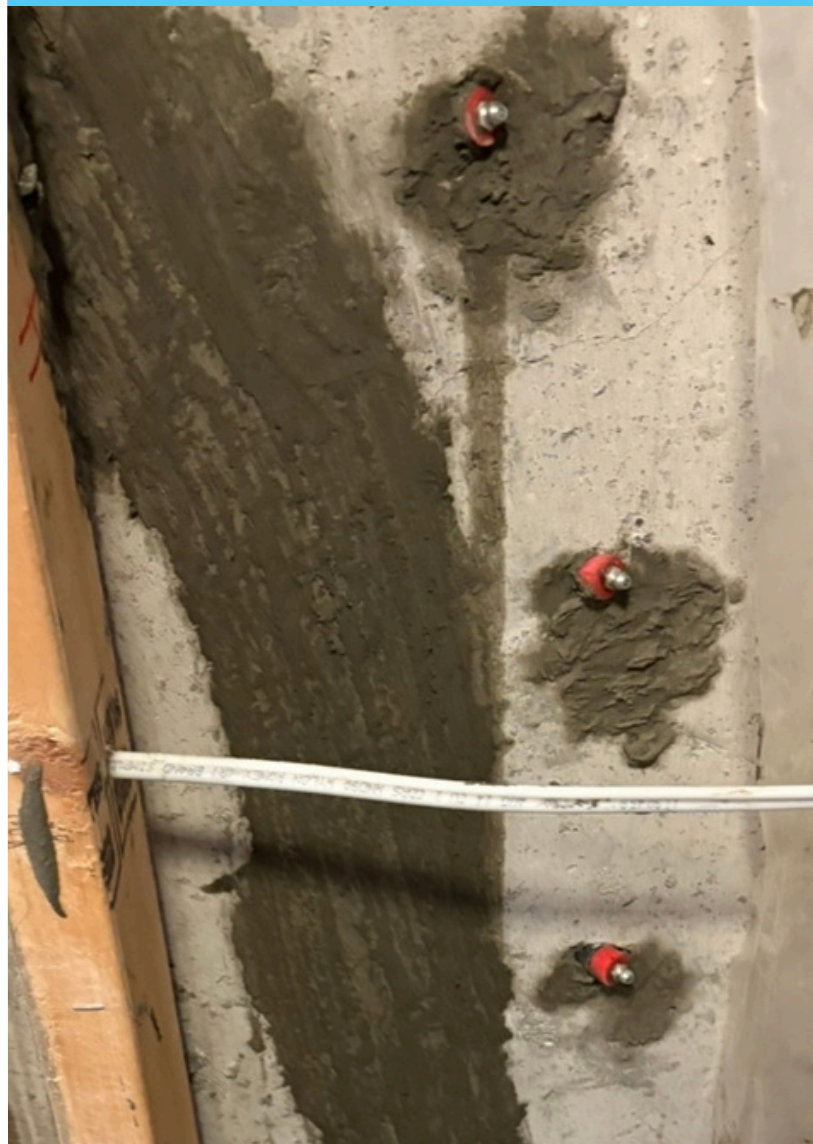
The Eco polyurethane sealant injection successfully sealed the foundation crack, eliminating water seepage and restoring the lower level to a dry condition. The low-viscosity polyurethane sealant effectively permeated the crack, forming a long-lasting waterproof barrier. Unlike rigid repair materials, the flexible nature of the polyurethane sealant allows for minor foundation movement without compromising the seal. The use of a pump made the injection process efficient and precise. The project provided a non-invasive, cost-effective, permanent solution, preventing further water damage, giving the home owners peace of mind. This project delivered a lasting, affordable, and non-disruptive solution, halting additional water damage and ensuring homeowner confidence.
